Stormwater Management Culvert Inventory

Town of Pelham, Massachusetts

Date: June 3, 2019

Date of Inspections: Winter 2018

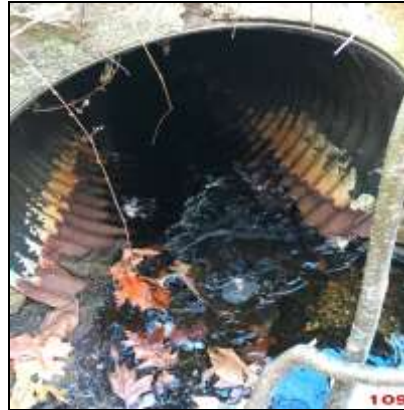
Outfall ID:	CUL-109-I
Street Name:	BUFFUM ROAD
Inlet/Outlet	Inlet
Inspection Date:	12/12/2018
Culvert Condition:	Poor
Culvert Diameter:	28
Culvert Height:	0
Culvert Width:	0
Culvert Shape:	Round
Culvert Material:	CMP
Culvert Bottom Type:	Engineered
Culvert Issue:	Pipe invert rusted out
Headwall Present:	Yes
Headwall Condition:	Fair
Headwall Material:	Stone
Wingwall Present:	Yes
Wingwall Material:	Stone
Wingwall Length:	70
Wingwall Condition:	Fair
Scouring:	No
High Water Signs:	No
Inspection Notes:	0

Visible Sediment:	No
Screened In:	No
Closest Pole:	29
Weather Condition:	Clear
Stream Condition:	Good
Pavement Condition:	Good
Roadway Sags:	No
Depth of Fill	12
Side Slopes	Sloped
Underground Utilities:	No

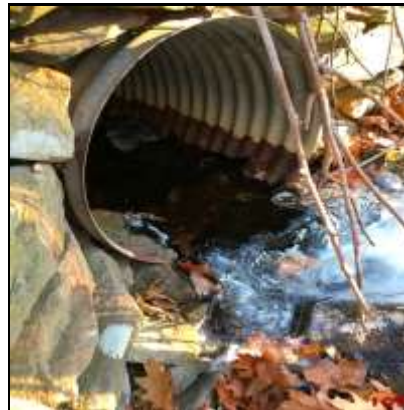
Outfall ID:	CUL-109-O
Street Name:	BUFFUM ROAD
Inlet/Outlet	Outlet
Inspection Date:	12/12/2018
Culvert Condition:	Poor
Culvert Diameter:	28
Culvert Height:	0
Culvert Width:	0
Culvert Shape:	Round
Culvert Material:	CMP
Culvert Bottom Type:	Engineered
Culvert Issue:	Pipe invert rusted out
Headwall Present:	Yes
Headwall Condition:	Fair
Headwall Material:	Stone
Wingwall Present:	Yes
Wingwall Material:	Stone
Wingwall Length:	70
Wingwall Condition:	Fair
Scouring:	No
High Water Signs:	No
Inspection Notes:	0

Visible Sediment:	No
Screened In:	No
Closest Pole:	29
Weather Condition:	Clear
Stream Condition:	Good
Pavement Condition:	Good
Roadway Sags:	No
Depth of Fill	12
Side Slopes	Sloped
Underground Utilities:	No

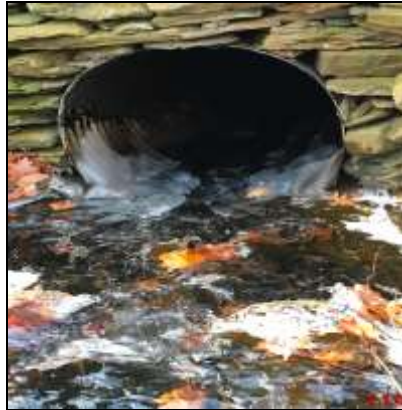
Outfall ID:	CUL-110-I
Street Name:	SHUTESBURY ROAD
Inlet/Outlet	Inlet
Inspection Date:	12/13/2018
Culvert Condition:	Good
Culvert Diameter:	36
Culvert Height:	0
Culvert Width:	0
Culvert Shape:	Round
Culvert Material:	CMP
Culvert Bottom Type:	Engineered
Culvert Issue:	None
Headwall Present:	Yes
Headwall Condition:	Good
Headwall Material:	Stone
Wingwall Present:	No
Wingwall Material:	None
Wingwall Length:	0
Wingwall Condition:	None
Scouring:	No
High Water Signs:	No
Inspection Notes:	0

Visible Sediment:	No
Screened In:	No
Closest Pole:	None
Weather Condition:	Clear
Stream Condition:	Good
Pavement Condition:	Good
Roadway Sags:	No
Depth of Fill	144
Side Slopes	Sloped
Underground Utilities:	No

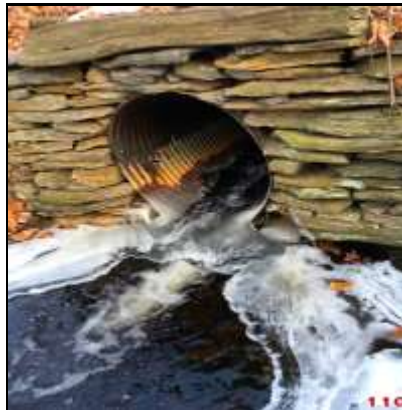
Outfall ID:	CUL-110-O
Street Name:	SHUTESBURY ROAD
Inlet/Outlet	Outlet
Inspection Date:	12/13/2018
Culvert Condition:	Good
Culvert Diameter:	36
Culvert Height:	0
Culvert Width:	0
Culvert Shape:	Round
Culvert Material:	CMP
Culvert Bottom Type:	Engineered
Culvert Issue:	None
Headwall Present:	Yes
Headwall Condition:	Good
Headwall Material:	Stone
Wingwall Present:	No
Wingwall Material:	None
Wingwall Length:	0
Wingwall Condition:	None
Scouring:	No
High Water Signs:	No
Inspection Notes:	0

Visible Sediment:	No
Screened In:	No
Closest Pole:	None
Weather Condition:	Clear
Stream Condition:	Good
Pavement Condition:	Good
Roadway Sags:	No
Depth of Fill	144
Side Slopes	Sloped
Underground Utilities:	No

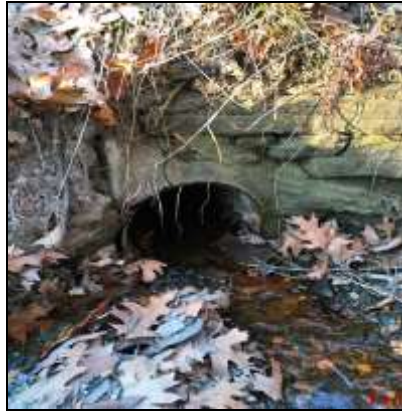
Outfall ID:	CUL-111-I
Street Name:	BUFFUM ROAD
Inlet/Outlet	Inlet
Inspection Date:	12/12/2018
Culvert Condition:	Poor
Culvert Diameter:	12
Culvert Height:	0
Culvert Width:	0
Culvert Shape:	Round
Culvert Material:	CMP
Culvert Bottom Type:	Engineered
Culvert Issue:	None
Headwall Present:	Yes
Headwall Condition:	Good
Headwall Material:	Stone
Wingwall Present:	Yes
Wingwall Material:	Stone
Wingwall Length:	36
Wingwall Condition:	Good
Scouring:	No
High Water Signs:	No
Inspection Notes:	0

Visible Sediment:	No
Screened In:	No
Closest Pole:	7
Weather Condition:	Clear
Stream Condition:	Good
Pavement Condition:	Good
Roadway Sags:	No
Depth of Fill	24
Side Slopes	Sloped
Underground Utilities:	No

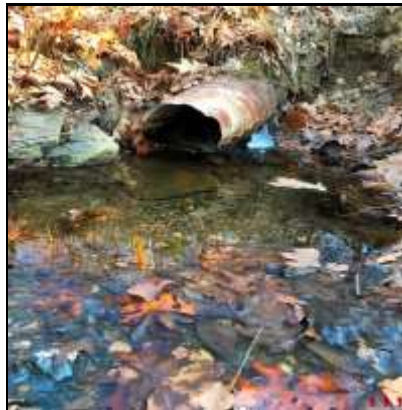
Outfall ID:	CUL-111-O
Street Name:	BUFFUM ROAD
Inlet/Outlet	Outlet
Inspection Date:	12/12/2018
Culvert Condition:	Poor
Culvert Diameter:	12
Culvert Height:	0
Culvert Width:	0
Culvert Shape:	Round
Culvert Material:	CMP
Culvert Bottom Type:	Engineered
Culvert Issue:	Pipe bottom rusted out
Headwall Present:	No
Headwall Condition:	None
Headwall Material:	None
Wingwall Present:	No
Wingwall Material:	None
Wingwall Length:	0
Wingwall Condition:	None
Scouring:	No
High Water Signs:	No
Inspection Notes:	0

Visible Sediment:	No
Screened In:	No
Closest Pole:	27
Weather Condition:	Clear
Stream Condition:	Good
Pavement Condition:	Good
Roadway Sags:	No
Depth of Fill	24
Side Slopes	Sloped
Underground Utilities:	No

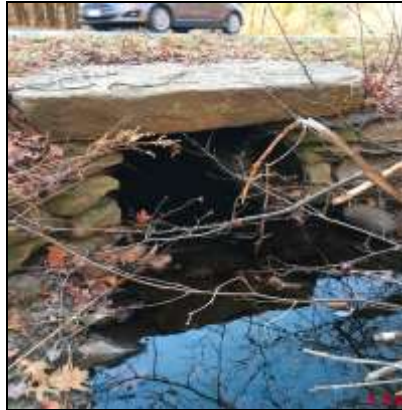
Outfall ID:	CUL-112-I
Street Name:	BUFFUM ROAD
Inlet/Outlet	Inlet
Inspection Date:	12/12/2018
Culvert Condition:	Good
Culvert Diameter:	0
Culvert Height:	28
Culvert Width:	40
Culvert Shape:	Other
Culvert Material:	CMP
Culvert Bottom Type:	Engineered
Culvert Issue:	None
Headwall Present:	Yes
Headwall Condition:	Fair
Headwall Material:	Stone
Wingwall Present:	Yes
Wingwall Material:	Stone
Wingwall Length:	24
Wingwall Condition:	Fair
Scouring:	No
High Water Signs:	No
Inspection Notes:	0

Visible Sediment:	No
Screened In:	No
Closest Pole:	23
Weather Condition:	Clear
Stream Condition:	Good
Pavement Condition:	Good
Roadway Sags:	No
Depth of Fill	12
Side Slopes	Sloped
Underground Utilities:	Yes

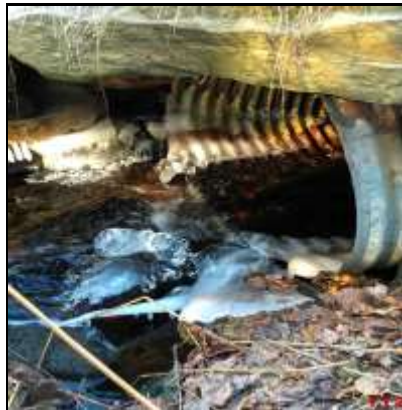
Outfall ID:	CUL-112-O
Street Name:	BUFFUM ROAD
Inlet/Outlet	Outlet
Inspection Date:	12/12/2018
Culvert Condition:	Good
Culvert Diameter:	0
Culvert Height:	28
Culvert Width:	40
Culvert Shape:	Other
Culvert Material:	CMP
Culvert Bottom Type:	Engineered
Culvert Issue:	None
Headwall Present:	Yes
Headwall Condition:	Fair
Headwall Material:	Stone
Wingwall Present:	No
Wingwall Material:	None
Wingwall Length:	0
Wingwall Condition:	None
Scouring:	No
High Water Signs:	No
Inspection Notes:	0

Visible Sediment:	No
Screened In:	No
Closest Pole:	23
Weather Condition:	Clear
Stream Condition:	Good
Pavement Condition:	Good
Roadway Sags:	No
Depth of Fill	12
Side Slopes	Sloped
Underground Utilities:	No

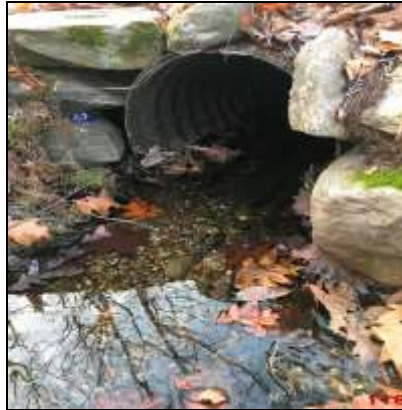
Outfall ID:	CUL-118-I
Street Name:	SHUTESBURY ROAD
Inlet/Outlet	Inlet
Inspection Date:	12/13/2018
Culvert Condition:	Poor
Culvert Diameter:	18
Culvert Height:	0
Culvert Width:	0
Culvert Shape:	Round
Culvert Material:	CMP
Culvert Bottom Type:	Engineered
Culvert Issue:	Pipe bottom rusted
Headwall Present:	Yes
Headwall Condition:	Fair
Headwall Material:	Stone
Wingwall Present:	No
Wingwall Material:	None
Wingwall Length:	0
Wingwall Condition:	None
Scouring:	No
High Water Signs:	No
Inspection Notes:	0

Visible Sediment:	No
Screened In:	No
Closest Pole:	16
Weather Condition:	Clear
Stream Condition:	Good
Pavement Condition:	Good
Roadway Sags:	No
Depth of Fill	24
Side Slopes	Sloped
Underground Utilities:	No

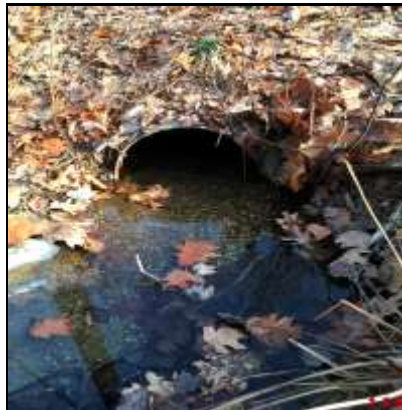
Outfall ID:	CUL-118-O
Street Name:	SHUTESBURY ROAD
Inlet/Outlet	Outlet
Inspection Date:	12/13/2018
Culvert Condition:	Fair
Culvert Diameter:	18
Culvert Height:	0
Culvert Width:	0
Culvert Shape:	Round
Culvert Material:	CMP
Culvert Bottom Type:	Engineered
Culvert Issue:	Pipe bottom rusted
Headwall Present:	No
Headwall Condition:	None
Headwall Material:	None
Wingwall Present:	No
Wingwall Material:	None
Wingwall Length:	0
Wingwall Condition:	None
Scouring:	No
High Water Signs:	No
Inspection Notes:	0

Visible Sediment:	No
Screened In:	No
Closest Pole:	16
Weather Condition:	Clear
Stream Condition:	Good
Pavement Condition:	Good
Roadway Sags:	No
Depth of Fill	24
Side Slopes	Sloped
Underground Utilities:	No

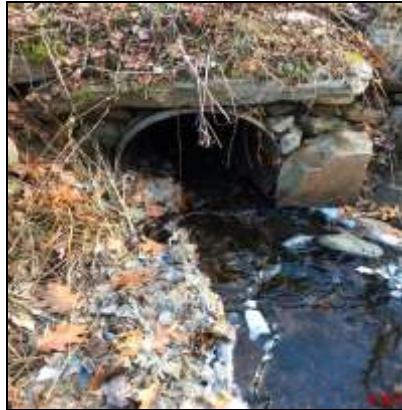
Outfall ID:	CUL-121-I
Street Name:	SHUTESBURY ROAD
Inlet/Outlet	Inlet
Inspection Date:	12/13/2018
Culvert Condition:	Good
Culvert Diameter:	24
Culvert Height:	0
Culvert Width:	0
Culvert Shape:	Round
Culvert Material:	CMP
Culvert Bottom Type:	Engineered
Culvert Issue:	None
Headwall Present:	Yes
Headwall Condition:	Fair
Headwall Material:	Stone
Wingwall Present:	No
Wingwall Material:	None
Wingwall Length:	0
Wingwall Condition:	None
Scouring:	No
High Water Signs:	No
Inspection Notes:	0

Visible Sediment:	No
Screened In:	No
Closest Pole:	22
Weather Condition:	Clear
Stream Condition:	Good
Pavement Condition:	Good
Roadway Sags:	No
Depth of Fill	36
Side Slopes	Sloped
Underground Utilities:	No

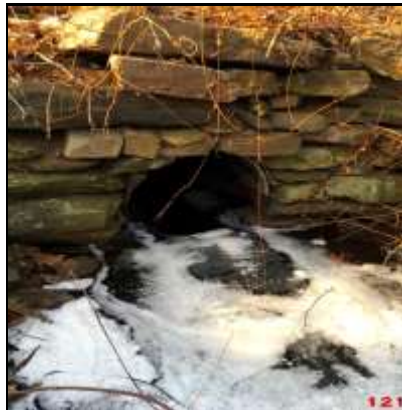
Outfall ID:	CUL-121-O
Street Name:	SHUTESBURY ROAD
Inlet/Outlet	Outlet
Inspection Date:	12/13/2018
Culvert Condition:	Good
Culvert Diameter:	24
Culvert Height:	0
Culvert Width:	0
Culvert Shape:	Round
Culvert Material:	CMP
Culvert Bottom Type:	Engineered
Culvert Issue:	None
Headwall Present:	Yes
Headwall Condition:	Fair
Headwall Material:	Stone
Wingwall Present:	No
Wingwall Material:	None
Wingwall Length:	0
Wingwall Condition:	None
Scouring:	No
High Water Signs:	No
Inspection Notes:	0

Visible Sediment:	No
Screened In:	No
Closest Pole:	22
Weather Condition:	Clear
Stream Condition:	Good
Pavement Condition:	Good
Roadway Sags:	No
Depth of Fill	36
Side Slopes	Sloped
Underground Utilities:	No

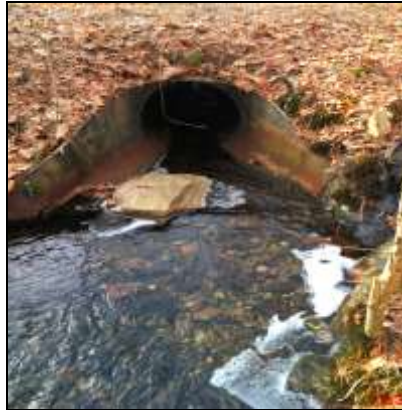
Outfall ID:	CUL-123-I
Street Name:	VALLEY ROAD
Inlet/Outlet	Inlet
Inspection Date:	12/13/2018
Culvert Condition:	Fair
Culvert Diameter:	36
Culvert Height:	0
Culvert Width:	0
Culvert Shape:	Round
Culvert Material:	CMP
Culvert Bottom Type:	Engineered
Culvert Issue:	None
Headwall Present:	No
Headwall Condition:	None
Headwall Material:	None
Wingwall Present:	No
Wingwall Material:	None
Wingwall Length:	0
Wingwall Condition:	None
Scouring:	No
High Water Signs:	No
Inspection Notes:	0

Visible Sediment:	No
Screened In:	No
Closest Pole:	56
Weather Condition:	Clear
Stream Condition:	Good
Pavement Condition:	Dirt/Gravel
Roadway Sags:	No
Depth of Fill	36
Side Slopes	Sloped
Underground Utilities:	No

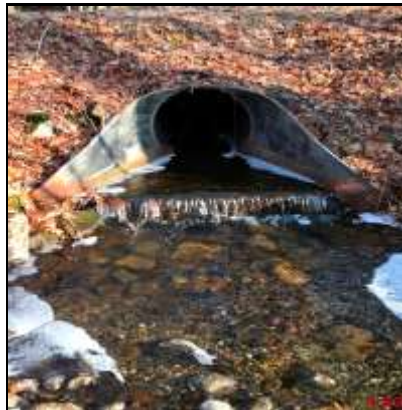
Outfall ID:	CUL-123-O
Street Name:	VALLEY ROAD
Inlet/Outlet	Outlet
Inspection Date:	12/13/2018
Culvert Condition:	Satisfactory
Culvert Diameter:	36
Culvert Height:	0
Culvert Width:	0
Culvert Shape:	Round
Culvert Material:	CMP
Culvert Bottom Type:	Engineered
Culvert Issue:	None
Headwall Present:	No
Headwall Condition:	None
Headwall Material:	None
Wingwall Present:	No
Wingwall Material:	None
Wingwall Length:	0
Wingwall Condition:	None
Scouring:	No
High Water Signs:	No
Inspection Notes:	0

Visible Sediment:	No
Screened In:	No
Closest Pole:	56
Weather Condition:	Clear
Stream Condition:	Good
Pavement Condition:	Dirt/Gravel
Roadway Sags:	No
Depth of Fill	36
Side Slopes	Sloped
Underground Utilities:	No

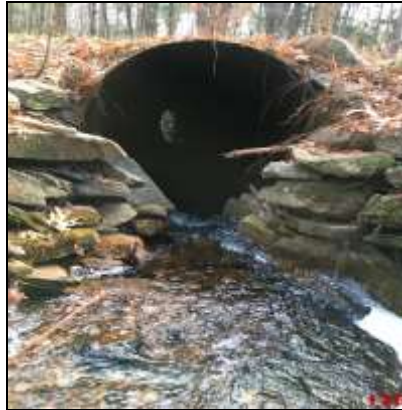
Outfall ID:	CUL-125-I
Street Name:	BUFFUM ROAD
Inlet/Outlet	Inlet
Inspection Date:	12/12/2018
Culvert Condition:	Good
Culvert Diameter:	0
Culvert Height:	60
Culvert Width:	60
Culvert Shape:	Irregular
Culvert Material:	OTHER
Culvert Bottom Type:	Natural
Culvert Issue:	None
Headwall Present:	No
Headwall Condition:	None
Headwall Material:	None
Wingwall Present:	No
Wingwall Material:	None
Wingwall Length:	0
Wingwall Condition:	None
Scouring:	No
High Water Signs:	No
Inspection Notes:	Stone culvert, 60" in upstream side, pipe ends halfway through culvert

Visible Sediment:	No
Screened In:	No
Closest Pole:	5
Weather Condition:	Clear
Stream Condition:	Good
Pavement Condition:	Good
Roadway Sags:	No
Depth of Fill	6
Side Slopes	Sloped
Underground Utilities:	No

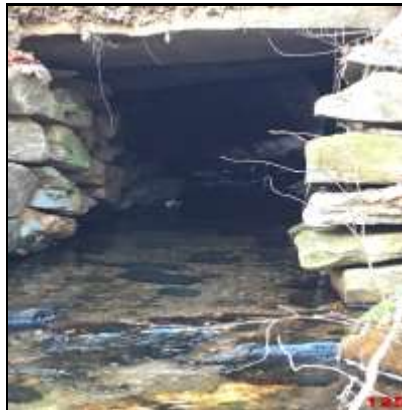
Outfall ID:	CUL-125-O
Street Name:	BUFFUM ROAD
Inlet/Outlet	Outlet
Inspection Date:	12/12/2018
Culvert Condition:	Good
Culvert Diameter:	0
Culvert Height:	60
Culvert Width:	60
Culvert Shape:	Irregular
Culvert Material:	OTHER
Culvert Bottom Type:	Natural
Culvert Issue:	None
Headwall Present:	No
Headwall Condition:	None
Headwall Material:	None
Wingwall Present:	No
Wingwall Material:	None
Wingwall Length:	0
Wingwall Condition:	None
Scouring:	No
High Water Signs:	No
Inspection Notes:	Stone culvert, 60" in upstream side, pipe ends halfway through culvert

Visible Sediment:	No
Screened In:	No
Closest Pole:	5
Weather Condition:	Clear
Stream Condition:	Good
Pavement Condition:	Good
Roadway Sags:	No
Depth of Fill	6
Side Slopes	Sloped
Underground Utilities:	No

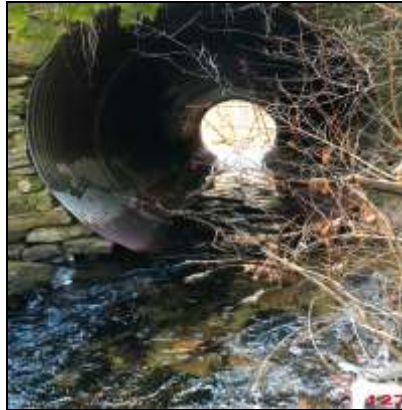
Outfall ID:	CUL-127-I
Street Name:	VALLEY ROAD
Inlet/Outlet	Inlet
Inspection Date:	12/12/2018
Culvert Condition:	Good
Culvert Diameter:	84
Culvert Height:	0
Culvert Width:	0
Culvert Shape:	Round
Culvert Material:	CMP
Culvert Bottom Type:	Engineered
Culvert Issue:	None
Headwall Present:	Yes
Headwall Condition:	Good
Headwall Material:	Stone
Wingwall Present:	No
Wingwall Material:	None
Wingwall Length:	0
Wingwall Condition:	None
Scouring:	No
High Water Signs:	No
Inspection Notes:	0

Visible Sediment:	No
Screened In:	No
Closest Pole:	28M
Weather Condition:	Clear
Stream Condition:	Good
Pavement Condition:	Good
Roadway Sags:	No
Depth of Fill	6
Side Slopes	Sloped
Underground Utilities:	No

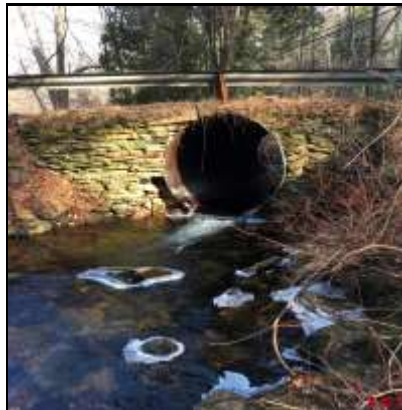
Outfall ID:	CUL-127-O
Street Name:	VALLEY ROAD
Inlet/Outlet	Outlet
Inspection Date:	12/12/2018
Culvert Condition:	Good
Culvert Diameter:	84
Culvert Height:	0
Culvert Width:	0
Culvert Shape:	Round
Culvert Material:	CMP
Culvert Bottom Type:	Engineered
Culvert Issue:	None
Headwall Present:	Yes
Headwall Condition:	Good
Headwall Material:	Stone
Wingwall Present:	No
Wingwall Material:	None
Wingwall Length:	0
Wingwall Condition:	None
Scouring:	No
High Water Signs:	No
Inspection Notes:	0

Visible Sediment:	No
Screened In:	No
Closest Pole:	28M
Weather Condition:	Clear
Stream Condition:	Good
Pavement Condition:	Good
Roadway Sags:	No
Depth of Fill	6
Side Slopes	Sloped
Underground Utilities:	No

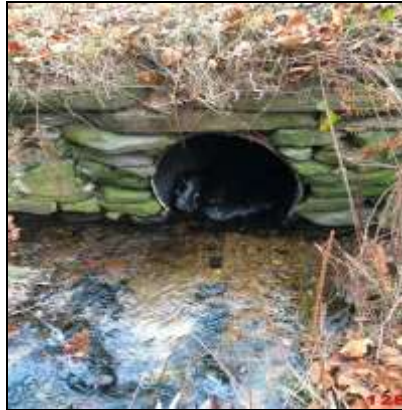
Outfall ID:	CUL-128-I
Street Name:	VALLEY ROAD
Inlet/Outlet	Inlet
Inspection Date:	12/12/2018
Culvert Condition:	Good
Culvert Diameter:	36
Culvert Height:	0
Culvert Width:	0
Culvert Shape:	Round
Culvert Material:	CMP
Culvert Bottom Type:	Engineered
Culvert Issue:	None
Headwall Present:	Yes
Headwall Condition:	Good
Headwall Material:	Stone
Wingwall Present:	No
Wingwall Material:	None
Wingwall Length:	0
Wingwall Condition:	None
Scouring:	No
High Water Signs:	No
Inspection Notes:	0

Visible Sediment:	No
Screened In:	No
Closest Pole:	21
Weather Condition:	Clear
Stream Condition:	Good
Pavement Condition:	Good
Roadway Sags:	No
Depth of Fill	36
Side Slopes	Sloped
Underground Utilities:	No

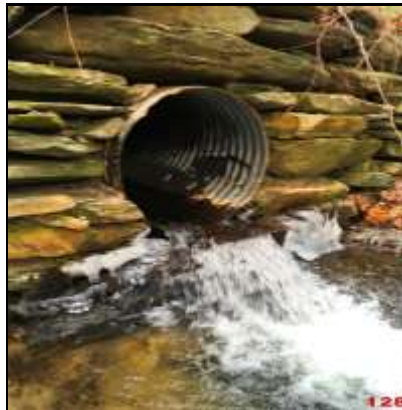
Outfall ID:	CUL-128-O
Street Name:	VALLEY ROAD
Inlet/Outlet	Outlet
Inspection Date:	12/12/2018
Culvert Condition:	Good
Culvert Diameter:	36
Culvert Height:	0
Culvert Width:	0
Culvert Shape:	Round
Culvert Material:	CMP
Culvert Bottom Type:	Engineered
Culvert Issue:	None
Headwall Present:	Yes
Headwall Condition:	Good
Headwall Material:	Stone
Wingwall Present:	No
Wingwall Material:	None
Wingwall Length:	0
Wingwall Condition:	None
Scouring:	No
High Water Signs:	No
Inspection Notes:	0

Visible Sediment:	No
Screened In:	Yes
Closest Pole:	21
Weather Condition:	Clear
Stream Condition:	Good
Pavement Condition:	Good
Roadway Sags:	No
Depth of Fill	36
Side Slopes	Sloped
Underground Utilities:	No

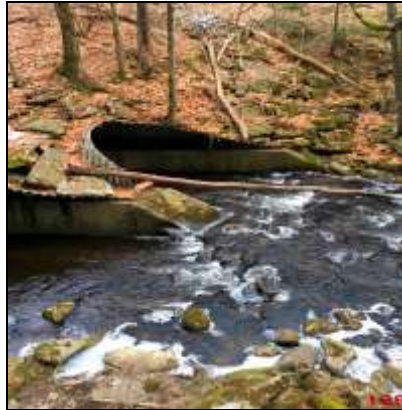
Outfall ID:	CUL-129-I
Street Name:	VALLEY ROAD
Inlet/Outlet	Inlet
Inspection Date:	12/12/2018
Culvert Condition:	Good
Culvert Diameter:	120
Culvert Height:	0
Culvert Width:	0
Culvert Shape:	Round
Culvert Material:	CMP
Culvert Bottom Type:	Natural
Culvert Issue:	None
Headwall Present:	No
Headwall Condition:	None
Headwall Material:	None
Wingwall Present:	No
Wingwall Material:	None
Wingwall Length:	0
Wingwall Condition:	None
Scouring:	No
High Water Signs:	No
Inspection Notes:	2 pipes ~120", no access for measurements

Visible Sediment:	No
Screened In:	No
Closest Pole:	6
Weather Condition:	Clear
Stream Condition:	Good
Pavement Condition:	Good
Roadway Sags:	No
Depth of Fill	120
Side Slopes	Sloped
Underground Utilities:	No

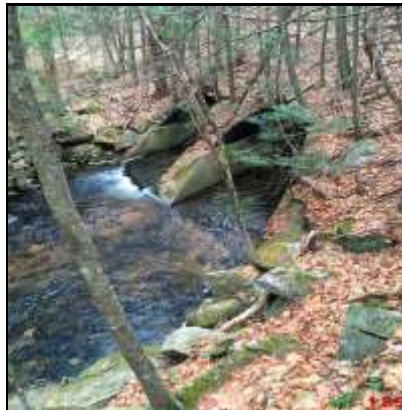
Outfall ID:	CUL-129-O
Street Name:	VALLEY ROAD
Inlet/Outlet	Outlet
Inspection Date:	12/12/2018
Culvert Condition:	Good
Culvert Diameter:	120
Culvert Height:	0
Culvert Width:	0
Culvert Shape:	Round
Culvert Material:	CMP
Culvert Bottom Type:	Natural
Culvert Issue:	None
Headwall Present:	No
Headwall Condition:	None
Headwall Material:	None
Wingwall Present:	No
Wingwall Material:	None
Wingwall Length:	0
Wingwall Condition:	None
Scouring:	No
High Water Signs:	No
Inspection Notes:	2 pipes ~120", no access for measurements

Visible Sediment:	No
Screened In:	No
Closest Pole:	6
Weather Condition:	Clear
Stream Condition:	Good
Pavement Condition:	Good
Roadway Sags:	No
Depth of Fill	120
Side Slopes	Sloped
Underground Utilities:	No

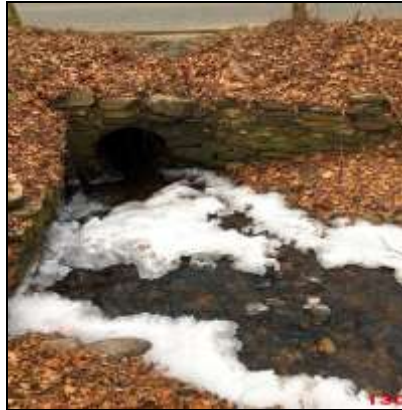
Outfall ID:	CUL-130-I
Street Name:	HARKNESS ROAD
Inlet/Outlet	Inlet
Inspection Date:	12/13/2018
Culvert Condition:	Satisfactory
Culvert Diameter:	36
Culvert Height:	0
Culvert Width:	0
Culvert Shape:	Round
Culvert Material:	CMP
Culvert Bottom Type:	Engineered
Culvert Issue:	None
Headwall Present:	Yes
Headwall Condition:	Fair
Headwall Material:	Stone
Wingwall Present:	Yes
Wingwall Material:	Stone
Wingwall Length:	74
Wingwall Condition:	Fair
Scouring:	No
High Water Signs:	No
Inspection Notes:	Nearby bollards w/o rails, poor condition

Visible Sediment:	No
Screened In:	No
Closest Pole:	34
Weather Condition:	Clear
Stream Condition:	Good
Pavement Condition:	Good
Roadway Sags:	No
Depth of Fill	24
Side Slopes	Sloped
Underground Utilities:	No

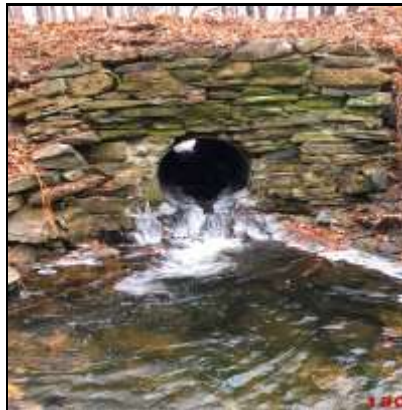
Outfall ID:	CUL-130-O
Street Name:	HARKNESS ROAD
Inlet/Outlet	Outlet
Inspection Date:	12/13/2018
Culvert Condition:	Satisfactory
Culvert Diameter:	36
Culvert Height:	0
Culvert Width:	0
Culvert Shape:	Round
Culvert Material:	CMP
Culvert Bottom Type:	Engineered
Culvert Issue:	None
Headwall Present:	Yes
Headwall Condition:	Fair
Headwall Material:	Stone
Wingwall Present:	No
Wingwall Material:	None
Wingwall Length:	0
Wingwall Condition:	None
Scouring:	No
High Water Signs:	No
Inspection Notes:	Nearby bollards w/o rails, poor condition

Visible Sediment:	No
Screened In:	No
Closest Pole:	34
Weather Condition:	Clear
Stream Condition:	Good
Pavement Condition:	Good
Roadway Sags:	No
Depth of Fill	24
Side Slopes	Sloped
Underground Utilities:	No

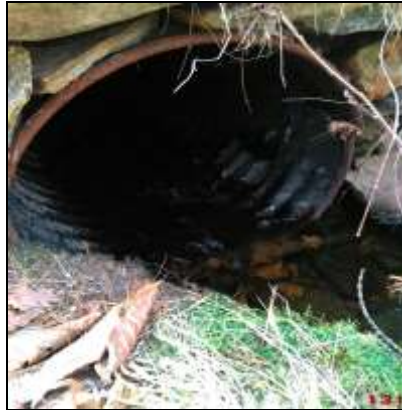
Outfall ID:	CUL-131-I
Street Name:	GATES ROAD
Inlet/Outlet	Inlet
Inspection Date:	12/12/2018
Culvert Condition:	Good
Culvert Diameter:	24
Culvert Height:	0
Culvert Width:	0
Culvert Shape:	Round
Culvert Material:	CMP
Culvert Bottom Type:	Engineered
Culvert Issue:	None
Headwall Present:	Yes
Headwall Condition:	Fair
Headwall Material:	Stone
Wingwall Present:	No
Wingwall Material:	None
Wingwall Length:	0
Wingwall Condition:	None
Scouring:	No
High Water Signs:	No
Inspection Notes:	0

Visible Sediment:	No
Screened In:	No
Closest Pole:	None
Weather Condition:	Clear
Stream Condition:	Good
Pavement Condition:	Dirt/Gravel
Roadway Sags:	No
Depth of Fill	12
Side Slopes	Sloped
Underground Utilities:	No

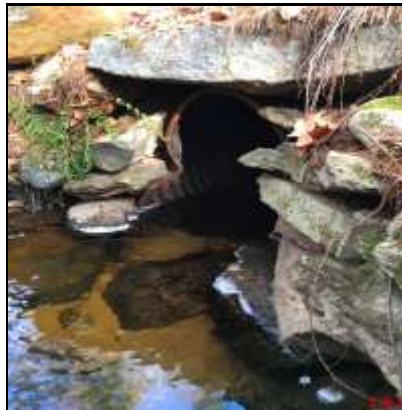
Outfall ID:	CUL-131-O
Street Name:	GATES ROAD
Inlet/Outlet	Outlet
Inspection Date:	12/12/2018
Culvert Condition:	Fair
Culvert Diameter:	24
Culvert Height:	0
Culvert Width:	0
Culvert Shape:	Round
Culvert Material:	CMP
Culvert Bottom Type:	Engineered
Culvert Issue:	None
Headwall Present:	Yes
Headwall Condition:	Fair
Headwall Material:	Stone
Wingwall Present:	No
Wingwall Material:	None
Wingwall Length:	0
Wingwall Condition:	None
Scouring:	No
High Water Signs:	No
Inspection Notes:	0

Visible Sediment:	No
Screened In:	No
Closest Pole:	None
Weather Condition:	Clear
Stream Condition:	Good
Pavement Condition:	Dirt/Gravel
Roadway Sags:	No
Depth of Fill	12
Side Slopes	Sloped
Underground Utilities:	No

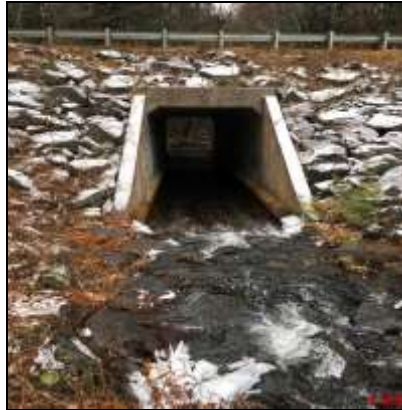
Outfall ID:	CUL-133-I
Street Name:	AMHERST ROAD
Inlet/Outlet	Inlet
Inspection Date:	12/14/2018
Culvert Condition:	Good
Culvert Diameter:	0
Culvert Height:	120
Culvert Width:	120
Culvert Shape:	Box
Culvert Material:	RCP
Culvert Bottom Type:	Engineered
Culvert Issue:	None
Headwall Present:	No
Headwall Condition:	None
Headwall Material:	None
Wingwall Present:	No
Wingwall Material:	None
Wingwall Length:	0
Wingwall Condition:	None
Scouring:	No
High Water Signs:	No
Inspection Notes:	0

Visible Sediment:	No
Screened In:	No
Closest Pole:	1 24
Weather Condition:	Cloudy
Stream Condition:	Good
Pavement Condition:	Good
Roadway Sags:	No
Depth of Fill	60
Side Slopes	Sloped
Underground Utilities:	No

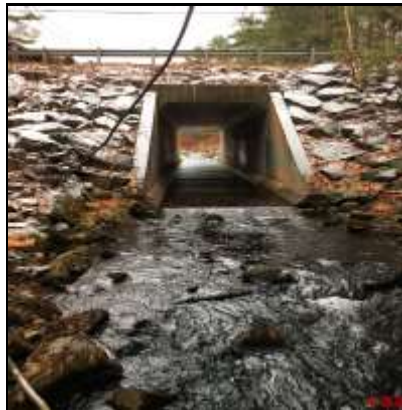
Outfall ID:	CUL-133-O
Street Name:	AMHERST ROAD
Inlet/Outlet	Outlet
Inspection Date:	12/14/2018
Culvert Condition:	Good
Culvert Diameter:	0
Culvert Height:	120
Culvert Width:	120
Culvert Shape:	Box
Culvert Material:	RCP
Culvert Bottom Type:	Engineered
Culvert Issue:	None
Headwall Present:	No
Headwall Condition:	None
Headwall Material:	None
Wingwall Present:	No
Wingwall Material:	None
Wingwall Length:	0
Wingwall Condition:	None
Scouring:	No
High Water Signs:	No
Inspection Notes:	0

Visible Sediment:	No
Screened In:	No
Closest Pole:	1 24
Weather Condition:	Cloudy
Stream Condition:	Good
Pavement Condition:	Good
Roadway Sags:	No
Depth of Fill	60
Side Slopes	Sloped
Underground Utilities:	No

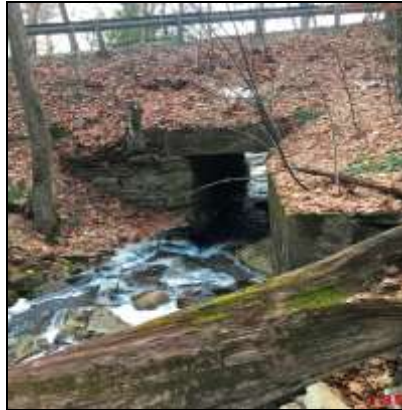
Outfall ID:	CUL-135-I
Street Name:	COOK ROAD
Inlet/Outlet	Inlet
Inspection Date:	12/12/2018
Culvert Condition:	Good
Culvert Diameter:	0
Culvert Height:	96
Culvert Width:	72
Culvert Shape:	Irregular
Culvert Material:	OTHER
Culvert Bottom Type:	Natural
Culvert Issue:	None
Headwall Present:	Yes
Headwall Condition:	Good
Headwall Material:	Stone
Wingwall Present:	No
Wingwall Material:	None
Wingwall Length:	0
Wingwall Condition:	None
Scouring:	No
High Water Signs:	No
Inspection Notes:	Stone culvert

Visible Sediment:	No
Screened In:	No
Closest Pole:	None
Weather Condition:	Clear
Stream Condition:	Good
Pavement Condition:	Dirt/Gravel
Roadway Sags:	No
Depth of Fill	120
Side Slopes	Sloped
Underground Utilities:	No

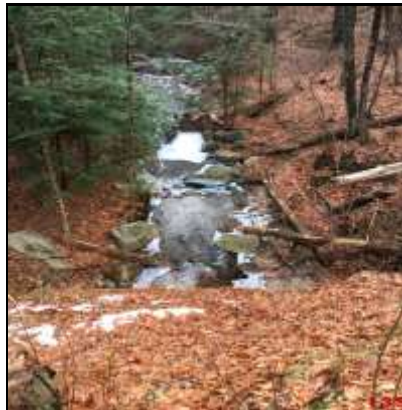
Outfall ID:	CUL-135-O
Street Name:	COOK ROAD
Inlet/Outlet	Outlet
Inspection Date:	12/12/2018
Culvert Condition:	Good
Culvert Diameter:	0
Culvert Height:	96
Culvert Width:	72
Culvert Shape:	Irregular
Culvert Material:	OTHER
Culvert Bottom Type:	Natural
Culvert Issue:	None
Headwall Present:	Yes
Headwall Condition:	Good
Headwall Material:	Stone
Wingwall Present:	No
Wingwall Material:	None
Wingwall Length:	0
Wingwall Condition:	None
Scouring:	No
High Water Signs:	No
Inspection Notes:	Stone culvert

Visible Sediment:	No
Screened In:	No
Closest Pole:	None
Weather Condition:	Clear
Stream Condition:	Good
Pavement Condition:	Dirt/Gravel
Roadway Sags:	No
Depth of Fill	120
Side Slopes	Sloped
Underground Utilities:	No

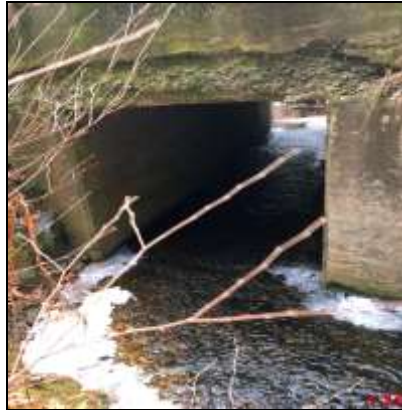
Outfall ID:	CUL-136-I
Street Name:	AMHERST ROAD
Inlet/Outlet	Inlet
Inspection Date:	12/14/2018
Culvert Condition:	Fair
Culvert Diameter:	0
Culvert Height:	60
Culvert Width:	66
Culvert Shape:	Box
Culvert Material:	RCP
Culvert Bottom Type:	Natural
Culvert Issue:	None
Headwall Present:	Yes
Headwall Condition:	Fair
Headwall Material:	Concrete
Wingwall Present:	No
Wingwall Material:	None
Wingwall Length:	0
Wingwall Condition:	None
Scouring:	Yes
High Water Signs:	No
Inspection Notes:	0

Visible Sediment:	No
Screened In:	No
Closest Pole:	104
Weather Condition:	Cloudy
Stream Condition:	Good
Pavement Condition:	Good
Roadway Sags:	No
Depth of Fill	60
Side Slopes	Sloped
Underground Utilities:	No

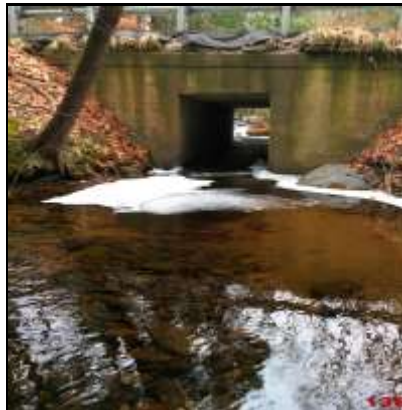
Outfall ID:	CUL-136-O
Street Name:	AMHERST ROAD
Inlet/Outlet	Outlet
Inspection Date:	12/14/2018
Culvert Condition:	Satisfactory
Culvert Diameter:	0
Culvert Height:	60
Culvert Width:	66
Culvert Shape:	Box
Culvert Material:	RCP
Culvert Bottom Type:	Natural
Culvert Issue:	None
Headwall Present:	Yes
Headwall Condition:	Good
Headwall Material:	Concrete
Wingwall Present:	No
Wingwall Material:	None
Wingwall Length:	0
Wingwall Condition:	None
Scouring:	No
High Water Signs:	No
Inspection Notes:	0

Visible Sediment:	No
Screened In:	No
Closest Pole:	104
Weather Condition:	Cloudy
Stream Condition:	Good
Pavement Condition:	Good
Roadway Sags:	No
Depth of Fill	60
Side Slopes	Sloped
Underground Utilities:	No

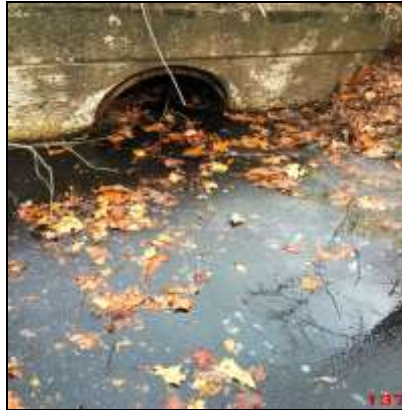
Visible Sediment:	No
Screened In:	No
Closest Pole:	None
Weather Condition:	Cloudy
Stream Condition:	Good
Pavement Condition:	Good
Roadway Sags:	No
Depth of Fill	36
Side Slopes	Sloped
Underground Utilities:	No

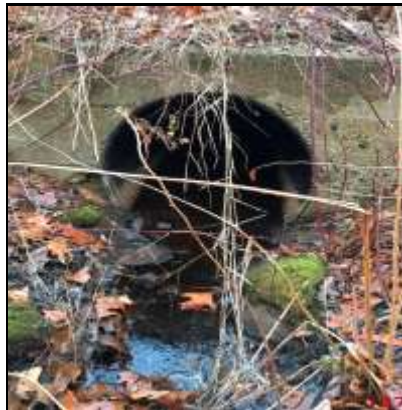
Visible Sediment:	No
Screened In:	No
Closest Pole:	1.126
Weather Condition:	Cloudy
Stream Condition:	Good
Pavement Condition:	Good
Roadway Sags:	No
Depth of Fill	36
Side Slopes	Sloped
Underground Utilities:	No

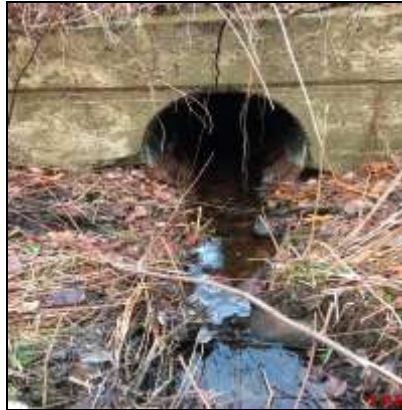
Visible Sediment:	No
Screened In:	No
Closest Pole:	1 135
Weather Condition:	Cloudy
Stream Condition:	Good
Pavement Condition:	Good
Roadway Sags:	No
Depth of Fill	30
Side Slopes	Sloped
Underground Utilities:	No

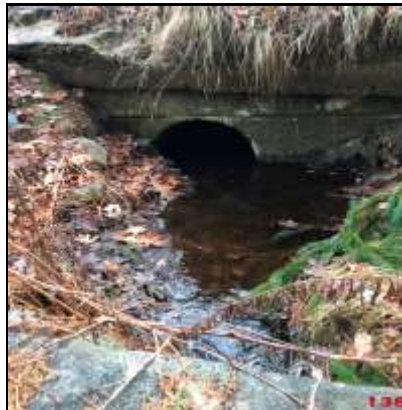
Visible Sediment:	No
Screened In:	No
Closest Pole:	1 135
Weather Condition:	Cloudy
Stream Condition:	Good
Pavement Condition:	Good
Roadway Sags:	No
Depth of Fill	30
Side Slopes	Sloped
Underground Utilities:	No

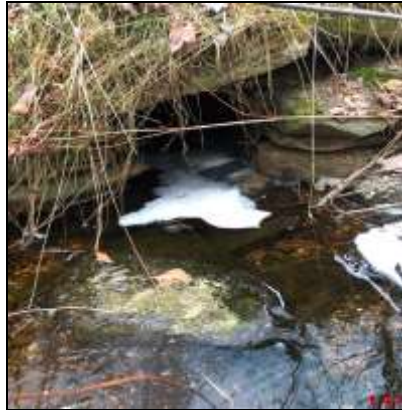
Visible Sediment:	Yes
Screened In:	No
Closest Pole:	2
Weather Condition:	Snow
Stream Condition:	Good
Pavement Condition:	Dirt/Gravel
Roadway Sags:	No
Depth of Fill	24
Side Slopes	Sloped
Underground Utilities:	No

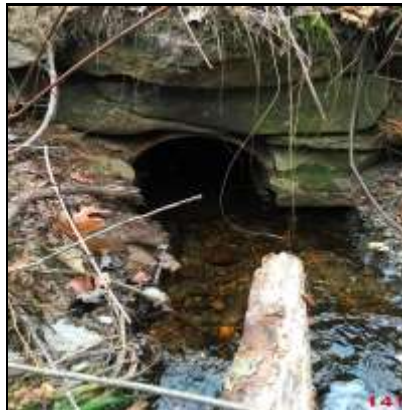
Visible Sediment:	Yes
Screened In:	No
Closest Pole:	2
Weather Condition:	Snow
Stream Condition:	Good
Pavement Condition:	Dirt/Gravel
Roadway Sags:	No
Depth of Fill	24
Side Slopes	Sloped
Underground Utilities:	No

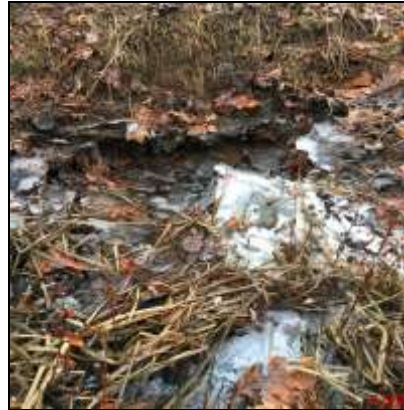
Visible Sediment:	Yes
Screened In:	No
Closest Pole:	73
Weather Condition:	Cloudy
Stream Condition:	Good
Pavement Condition:	Fair
Roadway Sags:	No
Depth of Fill	18
Side Slopes	Sloped
Underground Utilities:	No

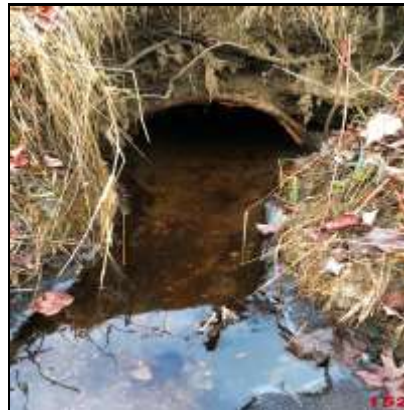
Visible Sediment:	Yes
Screened In:	No
Closest Pole:	73
Weather Condition:	Cloudy
Stream Condition:	Good
Pavement Condition:	Fair
Roadway Sags:	No
Depth of Fill	18
Side Slopes	Sloped
Underground Utilities:	No

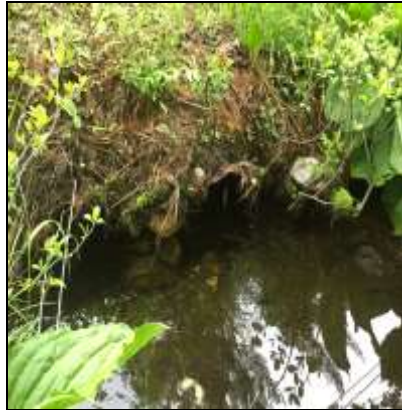
Visible Sediment:	Yes
Screened In:	No
Closest Pole:	72
Weather Condition:	Clear
Stream Condition:	Good
Pavement Condition:	Dirt/Gravel
Roadway Sags:	No
Depth of Fill	12
Side Slopes	Sloped
Underground Utilities:	No

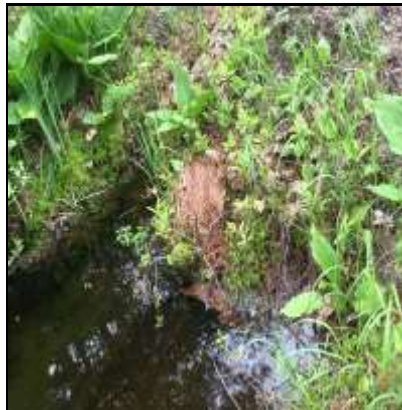
Visible Sediment:	Yes
Screened In:	No
Closest Pole:	72
Weather Condition:	Clear
Stream Condition:	Good
Pavement Condition:	Dirt/Gravel
Roadway Sags:	No
Depth of Fill	12
Side Slopes	Sloped
Underground Utilities:	No

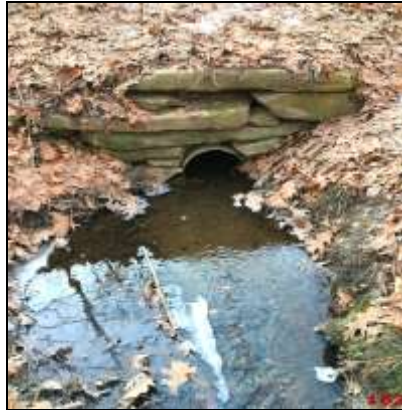
Visible Sediment:	Yes
Screened In:	No
Closest Pole:	5
Weather Condition:	Clear
Stream Condition:	Good
Pavement Condition:	Dirt/Gravel
Roadway Sags:	No
Depth of Fill	24
Side Slopes	Sloped
Underground Utilities:	No

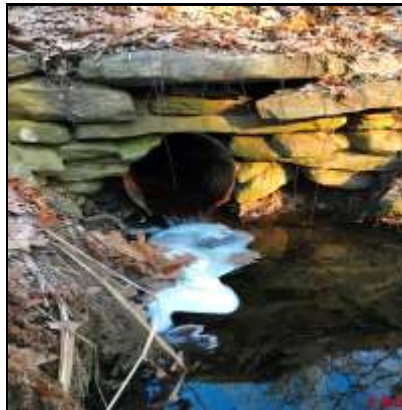
Visible Sediment:	No
Screened In:	No
Closest Pole:	5
Weather Condition:	Clear
Stream Condition:	Good
Pavement Condition:	Dirt/Gravel
Roadway Sags:	No
Depth of Fill	24
Side Slopes	Sloped
Underground Utilities:	No

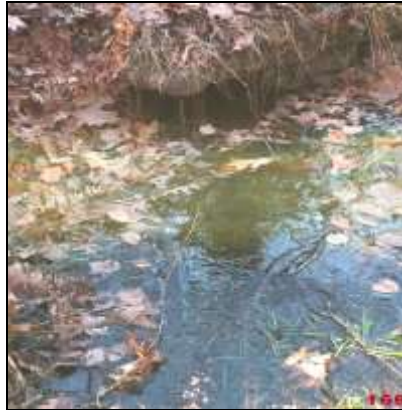
Visible Sediment:	No
Screened In:	No
Closest Pole:	20
Weather Condition:	Clear
Stream Condition:	Good
Pavement Condition:	Good
Roadway Sags:	No
Depth of Fill	24
Side Slopes	Sloped
Underground Utilities:	No

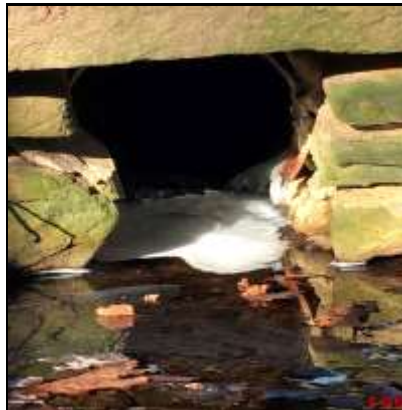
Visible Sediment:	No
Screened In:	No
Closest Pole:	20
Weather Condition:	Clear
Stream Condition:	Good
Pavement Condition:	Good
Roadway Sags:	No
Depth of Fill	24
Side Slopes	Sloped
Underground Utilities:	No

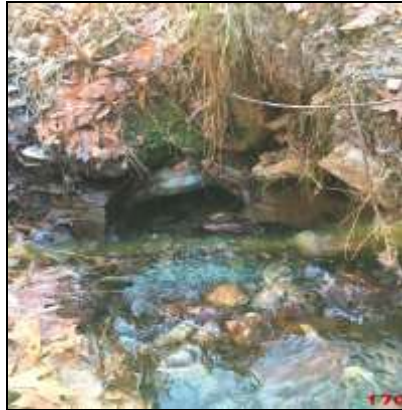
Visible Sediment:	Yes
Screened In:	No
Closest Pole:	8
Weather Condition:	Clear
Stream Condition:	Good
Pavement Condition:	Dirt/Gravel
Roadway Sags:	No
Depth of Fill	24
Side Slopes	Sloped
Underground Utilities:	No

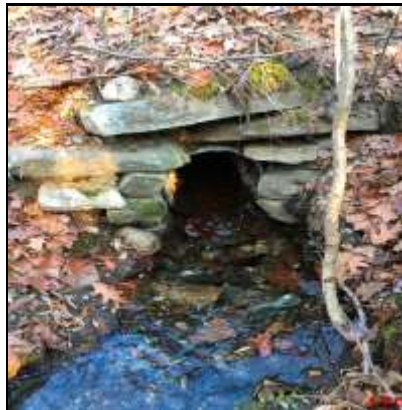
Visible Sediment:	No
Screened In:	No
Closest Pole:	8
Weather Condition:	Clear
Stream Condition:	Good
Pavement Condition:	Dirt/Gravel
Roadway Sags:	No
Depth of Fill	24
Side Slopes	Sloped
Underground Utilities:	No

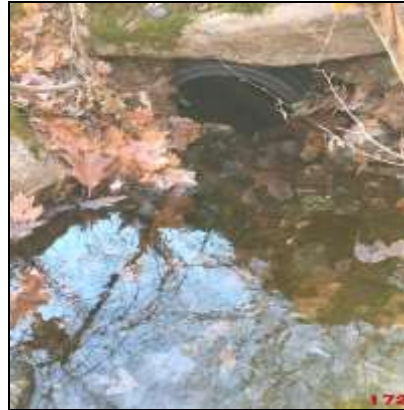
Visible Sediment:	Yes
Screened In:	No
Closest Pole:	None
Weather Condition:	Clear
Stream Condition:	Good
Pavement Condition:	Dirt/Gravel
Roadway Sags:	No
Depth of Fill	30
Side Slopes	Sloped
Underground Utilities:	No

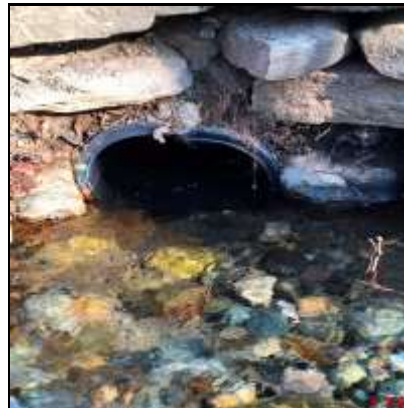
Visible Sediment:	No
Screened In:	No
Closest Pole:	None
Weather Condition:	Clear
Stream Condition:	Good
Pavement Condition:	Dirt/Gravel
Roadway Sags:	No
Depth of Fill	30
Side Slopes	Sloped
Underground Utilities:	No

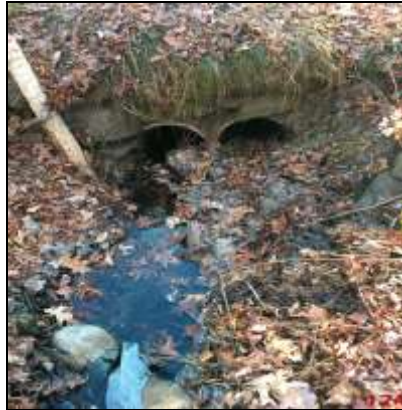
Visible Sediment:	Yes
Screened In:	No
Closest Pole:	17
Weather Condition:	Clear
Stream Condition:	Good
Pavement Condition:	Good
Roadway Sags:	No
Depth of Fill	24
Side Slopes	Sloped
Underground Utilities:	No

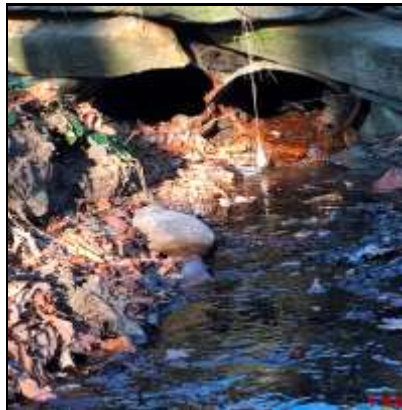
Visible Sediment:	No
Screened In:	No
Closest Pole:	17
Weather Condition:	Clear
Stream Condition:	Good
Pavement Condition:	Good
Roadway Sags:	No
Depth of Fill	24
Side Slopes	Sloped
Underground Utilities:	No

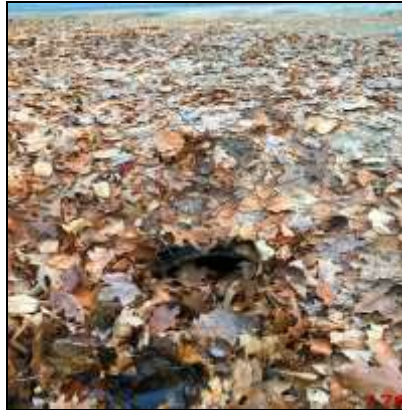
Visible Sediment:	Yes
Screened In:	No
Closest Pole:	12
Weather Condition:	Clear
Stream Condition:	Good
Pavement Condition:	Good
Roadway Sags:	No
Depth of Fill	18
Side Slopes	Sloped
Underground Utilities:	No

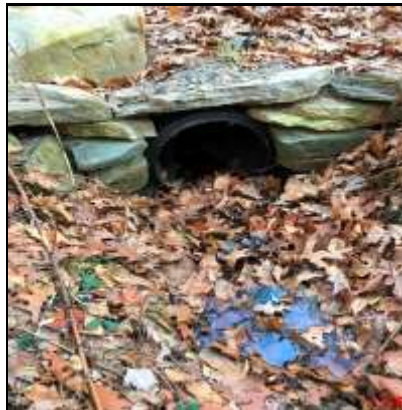
Visible Sediment:	Yes
Screened In:	No
Closest Pole:	12
Weather Condition:	Clear
Stream Condition:	Good
Pavement Condition:	Good
Roadway Sags:	No
Depth of Fill	18
Side Slopes	Sloped
Underground Utilities:	No

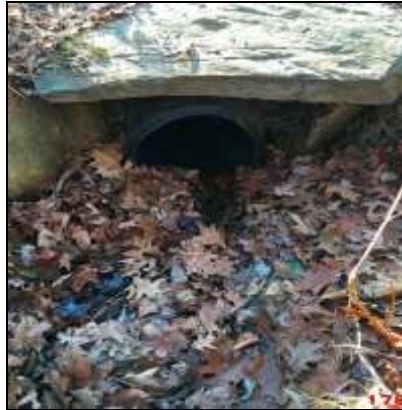
Visible Sediment:	Yes
Screened In:	No
Closest Pole:	10
Weather Condition:	Clear
Stream Condition:	Good
Pavement Condition:	Good
Roadway Sags:	No
Depth of Fill	18
Side Slopes	Sloped
Underground Utilities:	No

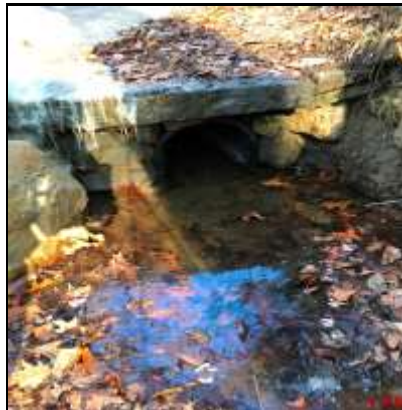
Visible Sediment:	Yes
Screened In:	No
Closest Pole:	10
Weather Condition:	Clear
Stream Condition:	Good
Pavement Condition:	Good
Roadway Sags:	No
Depth of Fill	18
Side Slopes	Sloped
Underground Utilities:	No
