Stormwater Management Culvert Inventory

Town of Pelham, Massachusetts

Date: June 3, 2019

Date of Inspections: Winter 2018

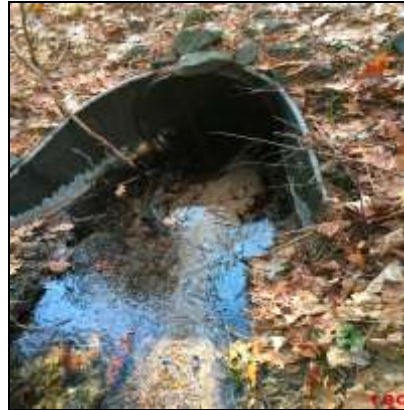
Outfall ID:	CUL-180-I
Street Name:	BUFFUM ROAD
Inlet/Outlet	Inlet
Inspection Date:	12/12/2018
Culvert Condition:	Good
Culvert Diameter:	24
Culvert Height:	0
Culvert Width:	0
Culvert Shape:	Round
Culvert Material:	CMP
Culvert Bottom Type:	Engineered
Culvert Issue:	None
Headwall Present:	No
Headwall Condition:	None
Headwall Material:	None
Wingwall Present:	No
Wingwall Material:	None
Wingwall Length:	0
Wingwall Condition:	None
Scouring:	No
High Water Signs:	No
Inspection Notes:	0

Visible Sediment:	Yes
Screened In:	No
Closest Pole:	561
Weather Condition:	Clear
Stream Condition:	Good
Pavement Condition:	Fair
Roadway Sags:	No
Depth of Fill	30
Side Slopes	Sloped
Underground Utilities:	No

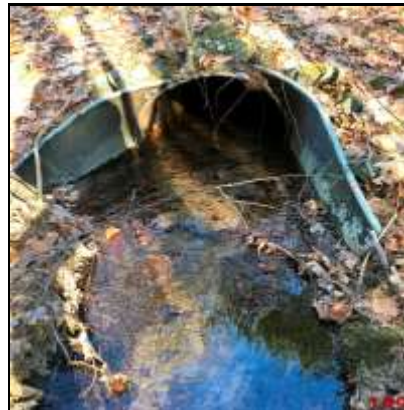
Outfall ID:	CUL-180-O
Street Name:	BUFFUM ROAD
Inlet/Outlet	Outlet
Inspection Date:	12/12/2018
Culvert Condition:	Good
Culvert Diameter:	24
Culvert Height:	0
Culvert Width:	0
Culvert Shape:	Round
Culvert Material:	CMP
Culvert Bottom Type:	Engineered
Culvert Issue:	None
Headwall Present:	No
Headwall Condition:	None
Headwall Material:	None
Wingwall Present:	No
Wingwall Material:	None
Wingwall Length:	0
Wingwall Condition:	None
Scouring:	No
High Water Signs:	No
Inspection Notes:	0

Visible Sediment:	Yes
Screened In:	No
Closest Pole:	561
Weather Condition:	Clear
Stream Condition:	Good
Pavement Condition:	Fair
Roadway Sags:	No
Depth of Fill	30
Side Slopes	Sloped
Underground Utilities:	No

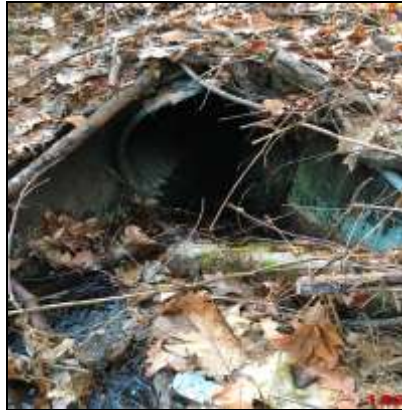
Outfall ID:	CUL-182-I
Street Name:	BUFFUM ROAD
Inlet/Outlet	Inlet
Inspection Date:	12/12/2018
Culvert Condition:	Good
Culvert Diameter:	21
Culvert Height:	0
Culvert Width:	0
Culvert Shape:	Round
Culvert Material:	CMP
Culvert Bottom Type:	Engineered
Culvert Issue:	None
Headwall Present:	No
Headwall Condition:	None
Headwall Material:	None
Wingwall Present:	No
Wingwall Material:	None
Wingwall Length:	0
Wingwall Condition:	None
Scouring:	No
High Water Signs:	No
Inspection Notes:	0

Visible Sediment:	Yes
Screened In:	No
Closest Pole:	561
Weather Condition:	Clear
Stream Condition:	Good
Pavement Condition:	Fair
Roadway Sags:	No
Depth of Fill	30
Side Slopes	Sloped
Underground Utilities:	No

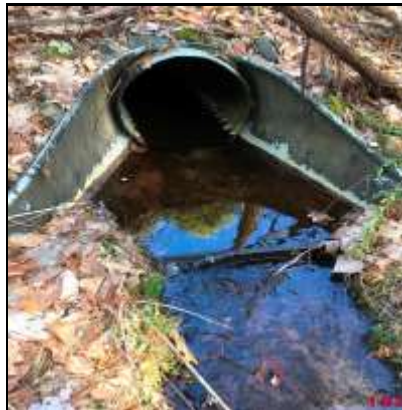
Outfall ID:	CUL-182-O
Street Name:	BUFFUM ROAD
Inlet/Outlet	Outlet
Inspection Date:	12/12/2018
Culvert Condition:	Good
Culvert Diameter:	21
Culvert Height:	0
Culvert Width:	0
Culvert Shape:	Round
Culvert Material:	CMP
Culvert Bottom Type:	Engineered
Culvert Issue:	None
Headwall Present:	No
Headwall Condition:	None
Headwall Material:	None
Wingwall Present:	No
Wingwall Material:	None
Wingwall Length:	0
Wingwall Condition:	None
Scouring:	No
High Water Signs:	No
Inspection Notes:	0

Visible Sediment:	Yes
Screened In:	No
Closest Pole:	561
Weather Condition:	Clear
Stream Condition:	Good
Pavement Condition:	Fair
Roadway Sags:	No
Depth of Fill	30
Side Slopes	Sloped
Underground Utilities:	No

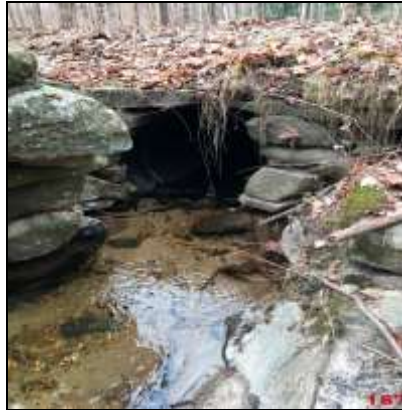
Outfall ID:	CUL-187-I
Street Name:	GATES ROAD
Inlet/Outlet	Inlet
Inspection Date:	12/12/2018
Culvert Condition:	Good
Culvert Diameter:	24
Culvert Height:	0
Culvert Width:	0
Culvert Shape:	Round
Culvert Material:	HDPE
Culvert Bottom Type:	Engineered
Culvert Issue:	None
Headwall Present:	Yes
Headwall Condition:	Fair
Headwall Material:	Stone
Wingwall Present:	No
Wingwall Material:	None
Wingwall Length:	0
Wingwall Condition:	None
Scouring:	No
High Water Signs:	No
Inspection Notes:	0

Visible Sediment:	No
Screened In:	No
Closest Pole:	11
Weather Condition:	Clear
Stream Condition:	Good
Pavement Condition:	Dirt/Gravel
Roadway Sags:	No
Depth of Fill	24
Side Slopes	Sloped
Underground Utilities:	No

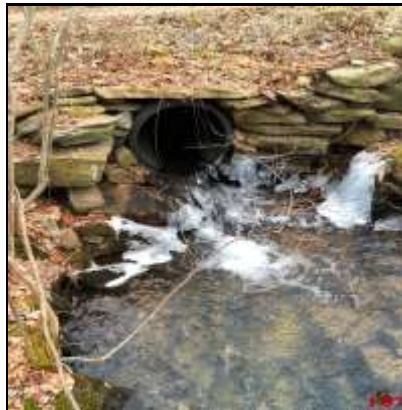
Outfall ID:	CUL-187-O
Street Name:	GATES ROAD
Inlet/Outlet	Outlet
Inspection Date:	12/12/2018
Culvert Condition:	Good
Culvert Diameter:	24
Culvert Height:	0
Culvert Width:	0
Culvert Shape:	Round
Culvert Material:	HDPE
Culvert Bottom Type:	Engineered
Culvert Issue:	None
Headwall Present:	Yes
Headwall Condition:	Fair
Headwall Material:	Stone
Wingwall Present:	No
Wingwall Material:	None
Wingwall Length:	0
Wingwall Condition:	None
Scouring:	No
High Water Signs:	No
Inspection Notes:	0

Visible Sediment:	No
Screened In:	No
Closest Pole:	11
Weather Condition:	Clear
Stream Condition:	Good
Pavement Condition:	Dirt/Gravel
Roadway Sags:	No
Depth of Fill	24
Side Slopes	Sloped
Underground Utilities:	No

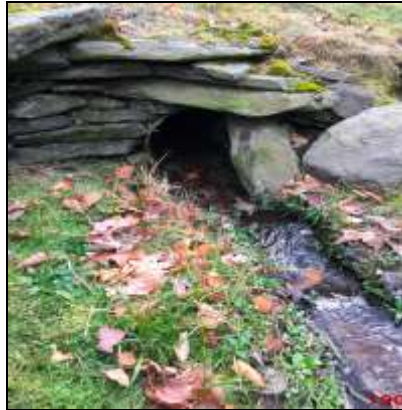
Outfall ID:	CUL-190-I
Street Name:	VALLEY ROAD
Inlet/Outlet	Inlet
Inspection Date:	12/12/2018
Culvert Condition:	Good
Culvert Diameter:	15
Culvert Height:	0
Culvert Width:	0
Culvert Shape:	Round
Culvert Material:	CMP
Culvert Bottom Type:	Engineered
Culvert Issue:	None
Headwall Present:	Yes
Headwall Condition:	Poor
Headwall Material:	Stone
Wingwall Present:	No
Wingwall Material:	None
Wingwall Length:	0
Wingwall Condition:	None
Scouring:	No
High Water Signs:	No
Inspection Notes:	0

Visible Sediment:	No
Screened In:	No
Closest Pole:	17
Weather Condition:	Clear
Stream Condition:	Good
Pavement Condition:	Good
Roadway Sags:	No
Depth of Fill	30
Side Slopes	Sloped
Underground Utilities:	No

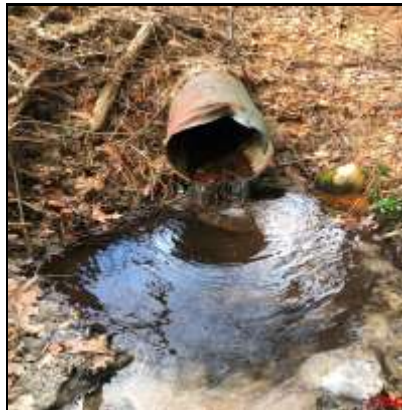
Outfall ID:	CUL-190-O
Street Name:	VALLEY ROAD
Inlet/Outlet	Outlet
Inspection Date:	12/12/2018
Culvert Condition:	Good
Culvert Diameter:	15
Culvert Height:	0
Culvert Width:	0
Culvert Shape:	Round
Culvert Material:	CMP
Culvert Bottom Type:	Engineered
Culvert Issue:	None
Headwall Present:	No
Headwall Condition:	None
Headwall Material:	None
Wingwall Present:	No
Wingwall Material:	None
Wingwall Length:	0
Wingwall Condition:	None
Scouring:	No
High Water Signs:	No
Inspection Notes:	0

Visible Sediment:	No
Screened In:	No
Closest Pole:	17
Weather Condition:	Clear
Stream Condition:	Good
Pavement Condition:	Good
Roadway Sags:	No
Depth of Fill	30
Side Slopes	Sloped
Underground Utilities:	No

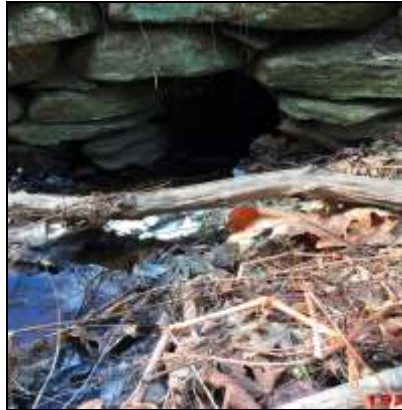
Outfall ID:	CUL-193-I
Street Name:	SOUTH VALLEY ROAD
Inlet/Outlet	Inlet
Inspection Date:	12/12/2018
Culvert Condition:	Satisfactory
Culvert Diameter:	12
Culvert Height:	0
Culvert Width:	0
Culvert Shape:	Round
Culvert Material:	CMP
Culvert Bottom Type:	Engineered
Culvert Issue:	Pipe starting to rust
Headwall Present:	Yes
Headwall Condition:	Fair
Headwall Material:	Stone
Wingwall Present:	No
Wingwall Material:	None
Wingwall Length:	0
Wingwall Condition:	None
Scouring:	No
High Water Signs:	No
Inspection Notes:	0

Visible Sediment:	No
Screened In:	No
Closest Pole:	23
Weather Condition:	Clear
Stream Condition:	Good
Pavement Condition:	Fair
Roadway Sags:	No
Depth of Fill	36
Side Slopes	Sloped
Underground Utilities:	No

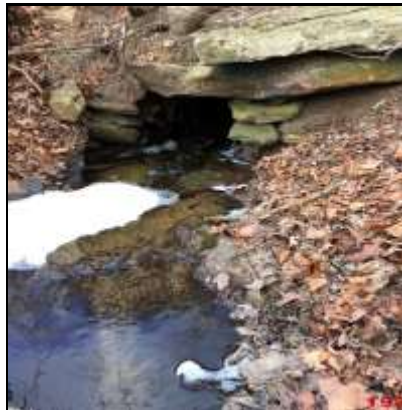
Outfall ID:	CUL-193-O
Street Name:	SOUTH VALLEY ROAD
Inlet/Outlet	Outlet
Inspection Date:	12/12/2018
Culvert Condition:	Satisfactory
Culvert Diameter:	12
Culvert Height:	0
Culvert Width:	0
Culvert Shape:	Round
Culvert Material:	CMP
Culvert Bottom Type:	Engineered
Culvert Issue:	Pipe starting to rust
Headwall Present:	Yes
Headwall Condition:	Fair
Headwall Material:	Stone
Wingwall Present:	No
Wingwall Material:	None
Wingwall Length:	0
Wingwall Condition:	None
Scouring:	No
High Water Signs:	No
Inspection Notes:	0

Visible Sediment:	Yes
Screened In:	No
Closest Pole:	23
Weather Condition:	Clear
Stream Condition:	Good
Pavement Condition:	Fair
Roadway Sags:	No
Depth of Fill	48
Side Slopes	Sloped
Underground Utilities:	No

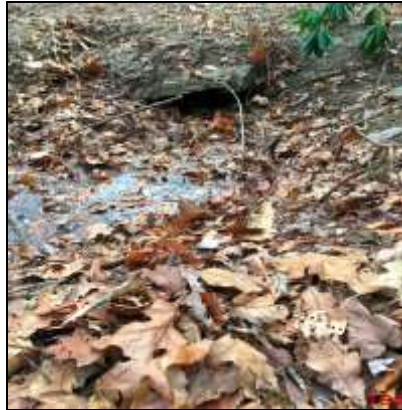
Outfall ID:	CUL-195-I
Street Name:	SOUTH VALLEY ROAD
Inlet/Outlet	Inlet
Inspection Date:	12/12/2018
Culvert Condition:	Serious
Culvert Diameter:	0
Culvert Height:	0
Culvert Width:	0
Culvert Shape:	Unknown
Culvert Material:	Unknown
Culvert Bottom Type:	Unknown
Culvert Issue:	Buried at both ends
Headwall Present:	No
Headwall Condition:	None
Headwall Material:	None
Wingwall Present:	No
Wingwall Material:	None
Wingwall Length:	0
Wingwall Condition:	None
Scouring:	No
High Water Signs:	No
Inspection Notes:	0

Visible Sediment:	Yes
Screened In:	No
Closest Pole:	24
Weather Condition:	Clear
Stream Condition:	Good
Pavement Condition:	Fair
Roadway Sags:	No
Depth of Fill	12
Side Slopes	Sloped
Underground Utilities:	No

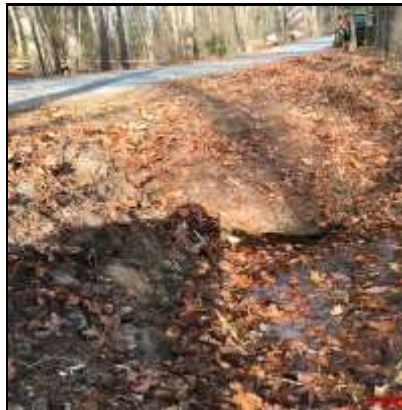
Outfall ID:	CUL-195-O
Street Name:	SOUTH VALLEY ROAD
Inlet/Outlet	Outlet
Inspection Date:	12/12/2018
Culvert Condition:	Serious
Culvert Diameter:	0
Culvert Height:	0
Culvert Width:	0
Culvert Shape:	Unknown
Culvert Material:	Unknown
Culvert Bottom Type:	Unknown
Culvert Issue:	Buried at both ends
Headwall Present:	No
Headwall Condition:	None
Headwall Material:	None
Wingwall Present:	No
Wingwall Material:	None
Wingwall Length:	0
Wingwall Condition:	None
Scouring:	No
High Water Signs:	No
Inspection Notes:	0

Visible Sediment:	Yes
Screened In:	No
Closest Pole:	24
Weather Condition:	Clear
Stream Condition:	Good
Pavement Condition:	Fair
Roadway Sags:	No
Depth of Fill	12
Side Slopes	Sloped
Underground Utilities:	No

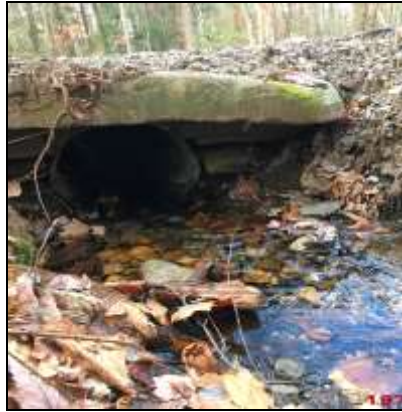
Outfall ID:	CUL-197-I
Street Name:	COOK ROAD
Inlet/Outlet	Inlet
Inspection Date:	12/12/2018
Culvert Condition:	Good
Culvert Diameter:	15
Culvert Height:	0
Culvert Width:	0
Culvert Shape:	Round
Culvert Material:	CMP
Culvert Bottom Type:	Engineered
Culvert Issue:	None
Headwall Present:	No
Headwall Condition:	None
Headwall Material:	None
Wingwall Present:	No
Wingwall Material:	None
Wingwall Length:	0
Wingwall Condition:	None
Scouring:	No
High Water Signs:	No
Inspection Notes:	0

Visible Sediment:	No
Screened In:	No
Closest Pole:	81
Weather Condition:	Clear
Stream Condition:	Good
Pavement Condition:	Dirt/Gravel
Roadway Sags:	No
Depth of Fill	12
Side Slopes	Flat
Underground Utilities:	No

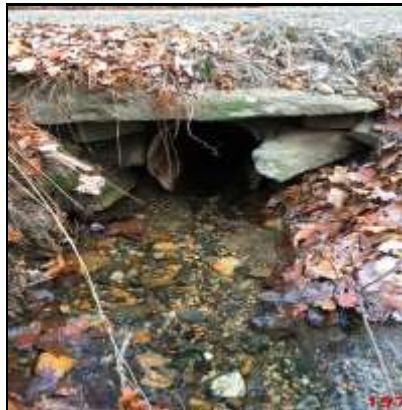
Outfall ID:	CUL-197-O
Street Name:	COOK ROAD
Inlet/Outlet	Outlet
Inspection Date:	12/12/2018
Culvert Condition:	Good
Culvert Diameter:	15
Culvert Height:	0
Culvert Width:	0
Culvert Shape:	Round
Culvert Material:	CMP
Culvert Bottom Type:	Engineered
Culvert Issue:	None
Headwall Present:	No
Headwall Condition:	None
Headwall Material:	None
Wingwall Present:	No
Wingwall Material:	None
Wingwall Length:	0
Wingwall Condition:	None
Scouring:	No
High Water Signs:	No
Inspection Notes:	0

Visible Sediment:	No
Screened In:	No
Closest Pole:	81
Weather Condition:	Clear
Stream Condition:	Good
Pavement Condition:	Dirt/Gravel
Roadway Sags:	No
Depth of Fill	12
Side Slopes	Flat
Underground Utilities:	No

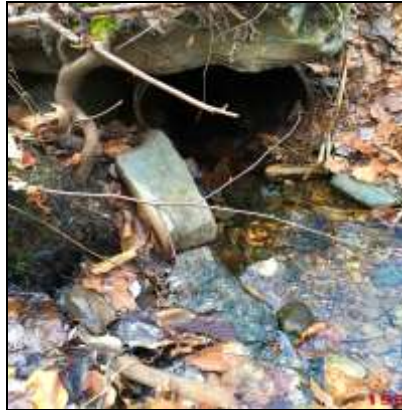
Outfall ID:	CUL-199-I
Street Name:	COOK ROAD
Inlet/Outlet	Inlet
Inspection Date:	12/12/2018
Culvert Condition:	Good
Culvert Diameter:	15
Culvert Height:	0
Culvert Width:	0
Culvert Shape:	Round
Culvert Material:	CMP
Culvert Bottom Type:	Engineered
Culvert Issue:	None
Headwall Present:	No
Headwall Condition:	None
Headwall Material:	None
Wingwall Present:	No
Wingwall Material:	None
Wingwall Length:	0
Wingwall Condition:	None
Scouring:	No
High Water Signs:	No
Inspection Notes:	0

Visible Sediment:	No
Screened In:	No
Closest Pole:	2
Weather Condition:	Clear
Stream Condition:	Good
Pavement Condition:	Dirt/Gravel
Roadway Sags:	No
Depth of Fill	12
Side Slopes	Sloped
Underground Utilities:	No

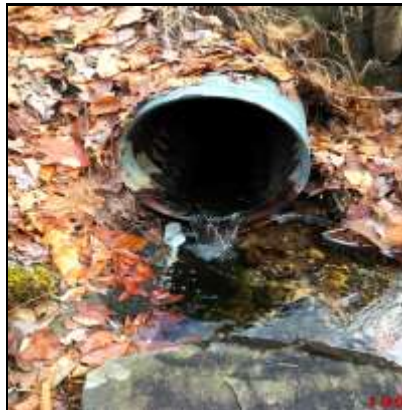
Outfall ID:	CUL-199-O
Street Name:	COOK ROAD
Inlet/Outlet	Outlet
Inspection Date:	12/12/2018
Culvert Condition:	Good
Culvert Diameter:	15
Culvert Height:	0
Culvert Width:	0
Culvert Shape:	Round
Culvert Material:	CMP
Culvert Bottom Type:	Engineered
Culvert Issue:	None
Headwall Present:	No
Headwall Condition:	None
Headwall Material:	None
Wingwall Present:	No
Wingwall Material:	None
Wingwall Length:	0
Wingwall Condition:	None
Scouring:	No
High Water Signs:	No
Inspection Notes:	0

Visible Sediment:	No
Screened In:	No
Closest Pole:	2
Weather Condition:	Clear
Stream Condition:	Good
Pavement Condition:	Dirt/Gravel
Roadway Sags:	No
Depth of Fill	12
Side Slopes	Sloped
Underground Utilities:	No

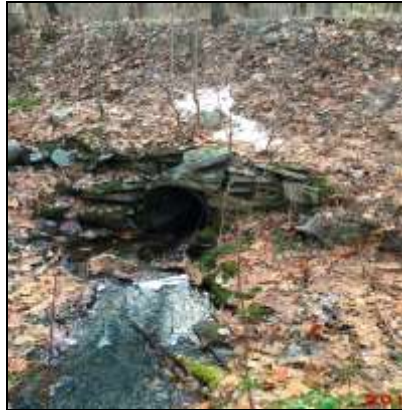
Outfall ID:	CUL-201-I
Street Name:	COOK ROAD
Inlet/Outlet	Inlet
Inspection Date:	12/12/2018
Culvert Condition:	Good
Culvert Diameter:	24
Culvert Height:	0
Culvert Width:	0
Culvert Shape:	Round
Culvert Material:	CMP
Culvert Bottom Type:	Engineered
Culvert Issue:	None
Headwall Present:	Yes
Headwall Condition:	Fair
Headwall Material:	Stone
Wingwall Present:	No
Wingwall Material:	None
Wingwall Length:	0
Wingwall Condition:	None
Scouring:	No
High Water Signs:	No
Inspection Notes:	0

Visible Sediment:	No
Screened In:	No
Closest Pole:	3
Weather Condition:	Clear
Stream Condition:	Good
Pavement Condition:	Dirt/Gravel
Roadway Sags:	No
Depth of Fill	36
Side Slopes	Sloped
Underground Utilities:	No

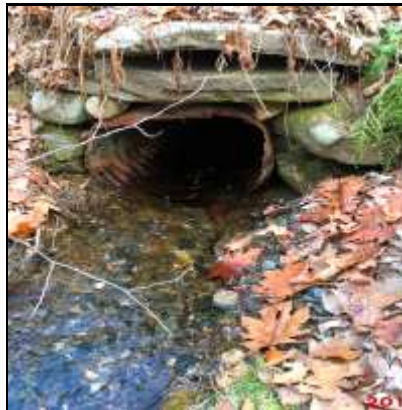
Outfall ID:	CUL-201-O
Street Name:	COOK ROAD
Inlet/Outlet	Outlet
Inspection Date:	12/12/2018
Culvert Condition:	Good
Culvert Diameter:	24
Culvert Height:	0
Culvert Width:	0
Culvert Shape:	Round
Culvert Material:	CMP
Culvert Bottom Type:	Engineered
Culvert Issue:	None
Headwall Present:	Yes
Headwall Condition:	Fair
Headwall Material:	Stone
Wingwall Present:	No
Wingwall Material:	None
Wingwall Length:	0
Wingwall Condition:	None
Scouring:	No
High Water Signs:	No
Inspection Notes:	0

Visible Sediment:	No
Screened In:	No
Closest Pole:	3
Weather Condition:	Clear
Stream Condition:	Good
Pavement Condition:	Dirt/Gravel
Roadway Sags:	No
Depth of Fill	36
Side Slopes	Sloped
Underground Utilities:	No

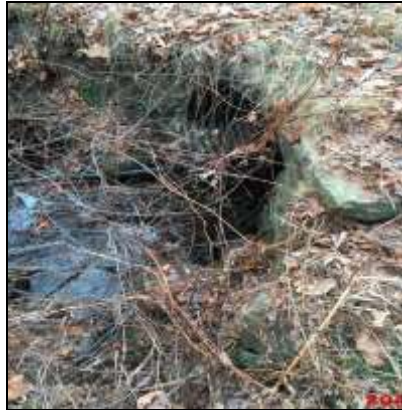
Outfall ID:	CUL-204-I
Street Name:	VALLEY ROAD
Inlet/Outlet	Inlet
Inspection Date:	12/13/2018
Culvert Condition:	Satisfactory
Culvert Diameter:	36
Culvert Height:	0
Culvert Width:	0
Culvert Shape:	Round
Culvert Material:	CMP
Culvert Bottom Type:	Engineered
Culvert Issue:	None
Headwall Present:	Yes
Headwall Condition:	Fair
Headwall Material:	Stone
Wingwall Present:	Yes
Wingwall Material:	Stone
Wingwall Length:	48
Wingwall Condition:	Fair
Scouring:	No
High Water Signs:	No
Inspection Notes:	0

Visible Sediment:	No
Screened In:	No
Closest Pole:	33
Weather Condition:	Clear
Stream Condition:	Good
Pavement Condition:	Fair
Roadway Sags:	No
Depth of Fill	24
Side Slopes	Sloped
Underground Utilities:	No

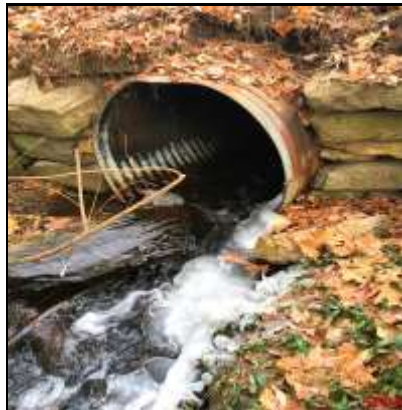
Outfall ID:	CUL-204-O
Street Name:	VALLEY ROAD
Inlet/Outlet	Outlet
Inspection Date:	12/13/2018
Culvert Condition:	Satisfactory
Culvert Diameter:	36
Culvert Height:	0
Culvert Width:	0
Culvert Shape:	Round
Culvert Material:	CMP
Culvert Bottom Type:	Engineered
Culvert Issue:	None
Headwall Present:	Yes
Headwall Condition:	Fair
Headwall Material:	Stone
Wingwall Present:	No
Wingwall Material:	None
Wingwall Length:	0
Wingwall Condition:	None
Scouring:	No
High Water Signs:	No
Inspection Notes:	0

Visible Sediment:	No
Screened In:	No
Closest Pole:	33
Weather Condition:	Clear
Stream Condition:	Good
Pavement Condition:	Fair
Roadway Sags:	No
Depth of Fill	24
Side Slopes	Sloped
Underground Utilities:	No

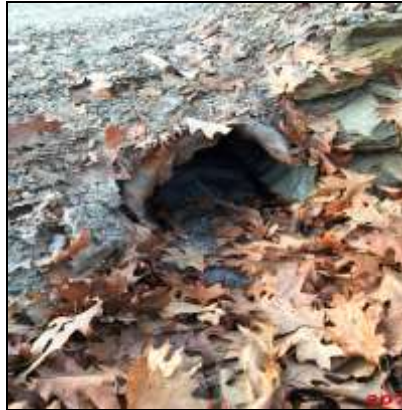
Outfall ID:	CUL-207-I
Street Name:	VALLEY ROAD
Inlet/Outlet	Inlet
Inspection Date:	12/13/2018
Culvert Condition:	Fair
Culvert Diameter:	12
Culvert Height:	0
Culvert Width:	0
Culvert Shape:	Round
Culvert Material:	CMP
Culvert Bottom Type:	Engineered
Culvert Issue:	None
Headwall Present:	No
Headwall Condition:	None
Headwall Material:	None
Wingwall Present:	No
Wingwall Material:	None
Wingwall Length:	0
Wingwall Condition:	None
Scouring:	No
High Water Signs:	No
Inspection Notes:	0

Visible Sediment:	No
Screened In:	No
Closest Pole:	81
Weather Condition:	Clear
Stream Condition:	Good
Pavement Condition:	Dirt/Gravel
Roadway Sags:	No
Depth of Fill	6
Side Slopes	Sloped
Underground Utilities:	No

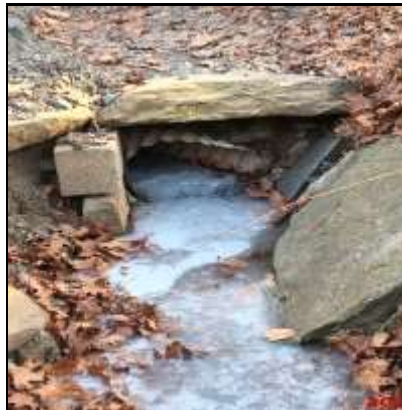
Outfall ID:	CUL-207-O
Street Name:	VALLEY ROAD
Inlet/Outlet	Outlet
Inspection Date:	12/13/2018
Culvert Condition:	Satisfactory
Culvert Diameter:	12
Culvert Height:	0
Culvert Width:	0
Culvert Shape:	Round
Culvert Material:	CMP
Culvert Bottom Type:	Engineered
Culvert Issue:	None
Headwall Present:	Yes
Headwall Condition:	Fair
Headwall Material:	Stone
Wingwall Present:	No
Wingwall Material:	None
Wingwall Length:	0
Wingwall Condition:	None
Scouring:	No
High Water Signs:	No
Inspection Notes:	0

Visible Sediment:	No
Screened In:	No
Closest Pole:	81
Weather Condition:	Clear
Stream Condition:	Good
Pavement Condition:	Dirt/Gravel
Roadway Sags:	No
Depth of Fill	6
Side Slopes	Sloped
Underground Utilities:	No

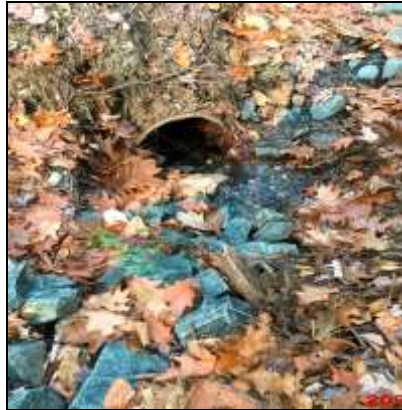
Outfall ID:	CUL-209-I
Street Name:	VALLEY ROAD
Inlet/Outlet	Inlet
Inspection Date:	12/13/2018
Culvert Condition:	Satisfactory
Culvert Diameter:	12
Culvert Height:	0
Culvert Width:	0
Culvert Shape:	Round
Culvert Material:	CMP
Culvert Bottom Type:	Engineered
Culvert Issue:	None
Headwall Present:	No
Headwall Condition:	None
Headwall Material:	None
Wingwall Present:	No
Wingwall Material:	None
Wingwall Length:	0
Wingwall Condition:	None
Scouring:	No
High Water Signs:	No
Inspection Notes:	0

Visible Sediment:	No
Screened In:	No
Closest Pole:	None
Weather Condition:	Clear
Stream Condition:	Good
Pavement Condition:	Dirt/Gravel
Roadway Sags:	No
Depth of Fill	6
Side Slopes	Sloped
Underground Utilities:	No

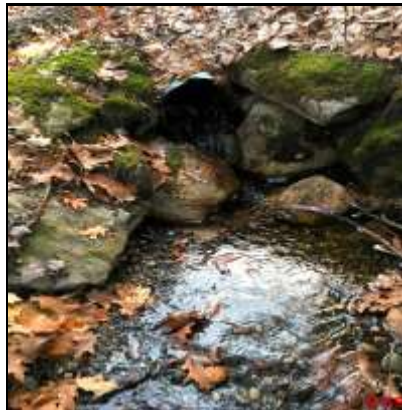
Outfall ID:	CUL-209-O
Street Name:	VALLEY ROAD
Inlet/Outlet	Outlet
Inspection Date:	12/13/2018
Culvert Condition:	Satisfactory
Culvert Diameter:	12
Culvert Height:	0
Culvert Width:	0
Culvert Shape:	Round
Culvert Material:	CMP
Culvert Bottom Type:	Engineered
Culvert Issue:	None
Headwall Present:	No
Headwall Condition:	None
Headwall Material:	None
Wingwall Present:	No
Wingwall Material:	None
Wingwall Length:	0
Wingwall Condition:	None
Scouring:	No
High Water Signs:	No
Inspection Notes:	0

Visible Sediment:	No
Screened In:	No
Closest Pole:	None
Weather Condition:	Clear
Stream Condition:	Good
Pavement Condition:	Dirt/Gravel
Roadway Sags:	No
Depth of Fill	6
Side Slopes	Sloped
Underground Utilities:	No

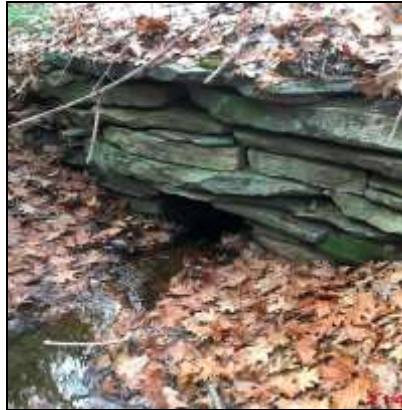
Outfall ID:	CUL-214-I
Street Name:	SHUTESBURY ROAD
Inlet/Outlet	Inlet
Inspection Date:	12/13/2018
Culvert Condition:	Good
Culvert Diameter:	24
Culvert Height:	0
Culvert Width:	0
Culvert Shape:	Round
Culvert Material:	CMP
Culvert Bottom Type:	Engineered
Culvert Issue:	None
Headwall Present:	Yes
Headwall Condition:	Good
Headwall Material:	Stone
Wingwall Present:	No
Wingwall Material:	None
Wingwall Length:	0
Wingwall Condition:	None
Scouring:	No
High Water Signs:	No
Inspection Notes:	0

Visible Sediment:	No
Screened In:	No
Closest Pole:	None
Weather Condition:	Clear
Stream Condition:	Good
Pavement Condition:	Good
Roadway Sags:	No
Depth of Fill	60
Side Slopes	Sloped
Underground Utilities:	No

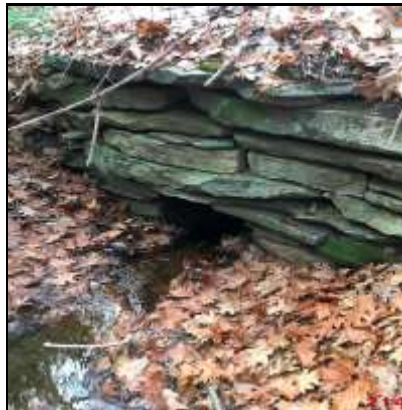
Outfall ID:	CUL-214-I
Street Name:	SHUTESBURY ROAD
Inlet/Outlet	Inlet
Inspection Date:	12/13/2018
Culvert Condition:	Good
Culvert Diameter:	24
Culvert Height:	0
Culvert Width:	0
Culvert Shape:	Round
Culvert Material:	CMP
Culvert Bottom Type:	Engineered
Culvert Issue:	None
Headwall Present:	Yes
Headwall Condition:	Good
Headwall Material:	Stone
Wingwall Present:	No
Wingwall Material:	None
Wingwall Length:	0
Wingwall Condition:	None
Scouring:	No
High Water Signs:	No
Inspection Notes:	0

Visible Sediment:	No
Screened In:	No
Closest Pole:	None
Weather Condition:	Clear
Stream Condition:	Good
Pavement Condition:	Good
Roadway Sags:	No
Depth of Fill	60
Side Slopes	Sloped
Underground Utilities:	No

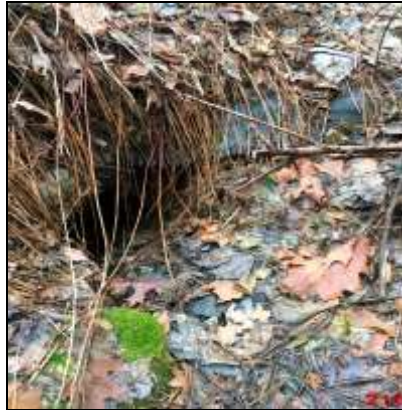
Outfall ID:	CUL-216-I
Street Name:	HARKNESS ROAD
Inlet/Outlet	Inlet
Inspection Date:	12/13/2018
Culvert Condition:	Good
Culvert Diameter:	12
Culvert Height:	0
Culvert Width:	0
Culvert Shape:	Round
Culvert Material:	HDPE
Culvert Bottom Type:	Engineered
Culvert Issue:	None
Headwall Present:	No
Headwall Condition:	None
Headwall Material:	None
Wingwall Present:	No
Wingwall Material:	None
Wingwall Length:	0
Wingwall Condition:	None
Scouring:	No
High Water Signs:	No
Inspection Notes:	May be private road, no name found

Visible Sediment:	Yes
Screened In:	No
Closest Pole:	None
Weather Condition:	Clear
Stream Condition:	Good
Pavement Condition:	Fair
Roadway Sags:	No
Depth of Fill	30
Side Slopes	Sloped
Underground Utilities:	No

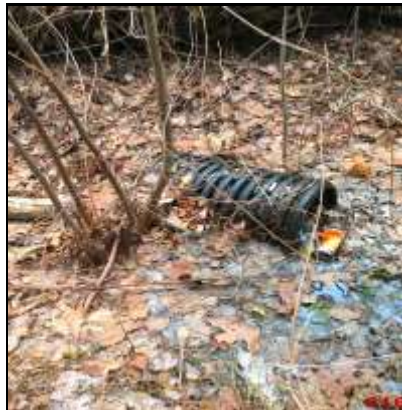
Outfall ID:	CUL-216-O
Street Name:	HARKNESS ROAD
Inlet/Outlet	Outlet
Inspection Date:	12/13/2018
Culvert Condition:	Good
Culvert Diameter:	12
Culvert Height:	0
Culvert Width:	0
Culvert Shape:	Round
Culvert Material:	HDPE
Culvert Bottom Type:	Engineered
Culvert Issue:	None
Headwall Present:	No
Headwall Condition:	None
Headwall Material:	None
Wingwall Present:	No
Wingwall Material:	None
Wingwall Length:	0
Wingwall Condition:	None
Scouring:	No
High Water Signs:	No
Inspection Notes:	May be private road, no name found

Visible Sediment:	Yes
Screened In:	No
Closest Pole:	None
Weather Condition:	Clear
Stream Condition:	Good
Pavement Condition:	Fair
Roadway Sags:	No
Depth of Fill	30
Side Slopes	Sloped
Underground Utilities:	No

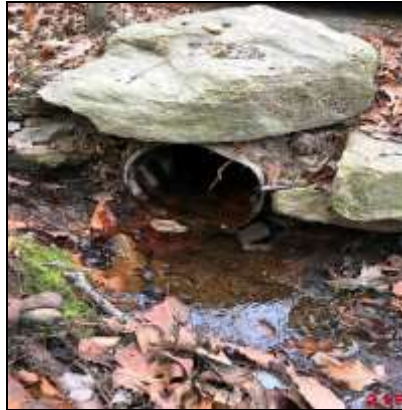
Outfall ID:	CUL-219-I
Street Name:	ARNOLD ROAD
Inlet/Outlet	Inlet
Inspection Date:	12/13/2018
Culvert Condition:	Good
Culvert Diameter:	12
Culvert Height:	0
Culvert Width:	0
Culvert Shape:	Round
Culvert Material:	CMP
Culvert Bottom Type:	Engineered
Culvert Issue:	None
Headwall Present:	Yes
Headwall Condition:	Fair
Headwall Material:	Stone
Wingwall Present:	No
Wingwall Material:	None
Wingwall Length:	0
Wingwall Condition:	None
Scouring:	No
High Water Signs:	No
Inspection Notes:	0

Visible Sediment:	Yes
Screened In:	No
Closest Pole:	10T
Weather Condition:	Clear
Stream Condition:	Red algae
Pavement Condition:	Good
Roadway Sags:	No
Depth of Fill	12
Side Slopes	Flat
Underground Utilities:	No

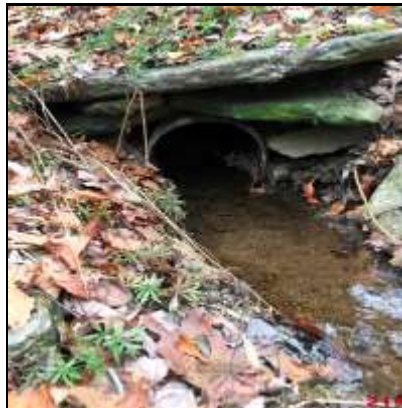
Outfall ID:	CUL-219-O
Street Name:	ARNOLD ROAD
Inlet/Outlet	Outlet
Inspection Date:	12/13/2018
Culvert Condition:	Good
Culvert Diameter:	12
Culvert Height:	0
Culvert Width:	0
Culvert Shape:	Round
Culvert Material:	CMP
Culvert Bottom Type:	Engineered
Culvert Issue:	None
Headwall Present:	Yes
Headwall Condition:	Fair
Headwall Material:	Stone
Wingwall Present:	No
Wingwall Material:	None
Wingwall Length:	0
Wingwall Condition:	None
Scouring:	No
High Water Signs:	No
Inspection Notes:	0

Visible Sediment:	Yes
Screened In:	No
Closest Pole:	10T
Weather Condition:	Clear
Stream Condition:	Good
Pavement Condition:	Good
Roadway Sags:	No
Depth of Fill	12
Side Slopes	Flat
Underground Utilities:	No

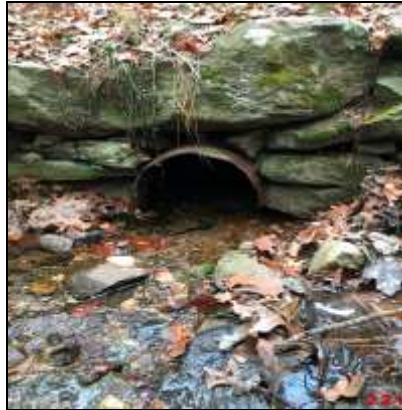
Outfall ID:	CUL-221-I
Street Name:	ARNOLD ROAD
Inlet/Outlet	Inlet
Inspection Date:	12/13/2018
Culvert Condition:	Good
Culvert Diameter:	12
Culvert Height:	0
Culvert Width:	0
Culvert Shape:	Round
Culvert Material:	CMP
Culvert Bottom Type:	Engineered
Culvert Issue:	None
Headwall Present:	Yes
Headwall Condition:	Fair
Headwall Material:	Stone
Wingwall Present:	No
Wingwall Material:	None
Wingwall Length:	0
Wingwall Condition:	None
Scouring:	No
High Water Signs:	No
Inspection Notes:	0

Visible Sediment:	Yes
Screened In:	No
Closest Pole:	27
Weather Condition:	Clear
Stream Condition:	Good
Pavement Condition:	Good
Roadway Sags:	No
Depth of Fill	12
Side Slopes	Sloped
Underground Utilities:	No

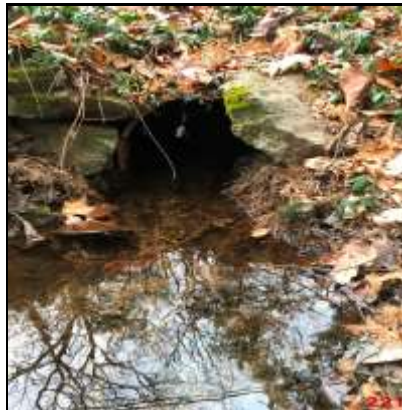
Outfall ID:	CUL-221-O
Street Name:	ARNOLD ROAD
Inlet/Outlet	Outlet
Inspection Date:	12/13/2018
Culvert Condition:	Good
Culvert Diameter:	12
Culvert Height:	0
Culvert Width:	0
Culvert Shape:	Round
Culvert Material:	CMP
Culvert Bottom Type:	Engineered
Culvert Issue:	None
Headwall Present:	Yes
Headwall Condition:	Fair
Headwall Material:	Stone
Wingwall Present:	No
Wingwall Material:	None
Wingwall Length:	0
Wingwall Condition:	None
Scouring:	No
High Water Signs:	No
Inspection Notes:	0

Visible Sediment:	Yes
Screened In:	No
Closest Pole:	27
Weather Condition:	Clear
Stream Condition:	Good
Pavement Condition:	Good
Roadway Sags:	No
Depth of Fill	12
Side Slopes	Sloped
Underground Utilities:	No

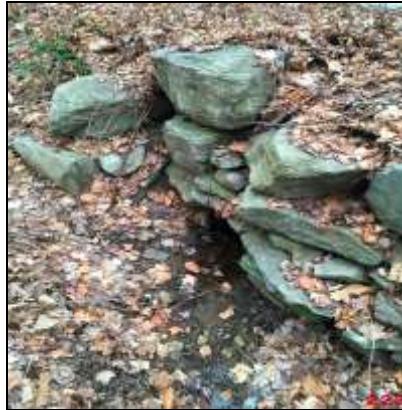
Outfall ID:	CUL-223-I
Street Name:	ARNOLD ROAD
Inlet/Outlet	Inlet
Inspection Date:	12/13/2018
Culvert Condition:	Good
Culvert Diameter:	18
Culvert Height:	0
Culvert Width:	0
Culvert Shape:	Round
Culvert Material:	CMP
Culvert Bottom Type:	Engineered
Culvert Issue:	None
Headwall Present:	Yes
Headwall Condition:	Fair
Headwall Material:	Stone
Wingwall Present:	No
Wingwall Material:	None
Wingwall Length:	0
Wingwall Condition:	None
Scouring:	No
High Water Signs:	No
Inspection Notes:	0

Visible Sediment:	Yes
Screened In:	No
Closest Pole:	9
Weather Condition:	Clear
Stream Condition:	Good
Pavement Condition:	Good
Roadway Sags:	No
Depth of Fill	36
Side Slopes	Sloped
Underground Utilities:	No

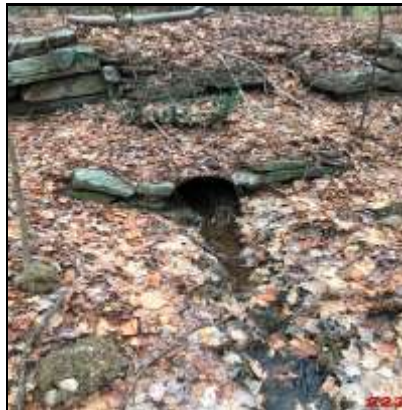
Outfall ID:	CUL-223-O
Street Name:	ARNOLD ROAD
Inlet/Outlet	Outlet
Inspection Date:	12/13/2018
Culvert Condition:	Good
Culvert Diameter:	18
Culvert Height:	0
Culvert Width:	0
Culvert Shape:	Round
Culvert Material:	CMP
Culvert Bottom Type:	Engineered
Culvert Issue:	None
Headwall Present:	Yes
Headwall Condition:	Fair
Headwall Material:	Stone
Wingwall Present:	No
Wingwall Material:	None
Wingwall Length:	0
Wingwall Condition:	None
Scouring:	No
High Water Signs:	No
Inspection Notes:	0

Visible Sediment:	Yes
Screened In:	No
Closest Pole:	9
Weather Condition:	Clear
Stream Condition:	Good
Pavement Condition:	Good
Roadway Sags:	No
Depth of Fill	36
Side Slopes	Sloped
Underground Utilities:	No

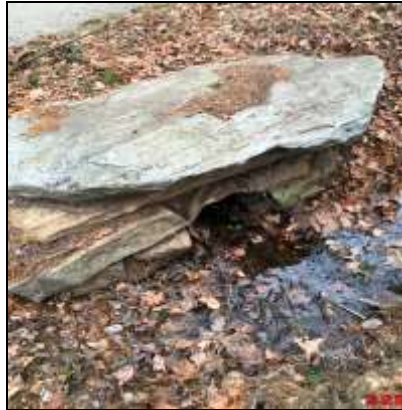
Outfall ID:	CUL-225-I
Street Name:	ARNOLD ROAD
Inlet/Outlet	Inlet
Inspection Date:	12/13/2018
Culvert Condition:	Satisfactory
Culvert Diameter:	12
Culvert Height:	0
Culvert Width:	0
Culvert Shape:	Round
Culvert Material:	CMP
Culvert Bottom Type:	Engineered
Culvert Issue:	None
Headwall Present:	Yes
Headwall Condition:	Fair
Headwall Material:	Stone
Wingwall Present:	No
Wingwall Material:	None
Wingwall Length:	0
Wingwall Condition:	None
Scouring:	No
High Water Signs:	No
Inspection Notes:	0

Visible Sediment:	Yes
Screened In:	No
Closest Pole:	11
Weather Condition:	Clear
Stream Condition:	Good
Pavement Condition:	Good
Roadway Sags:	No
Depth of Fill	12
Side Slopes	Sloped
Underground Utilities:	No

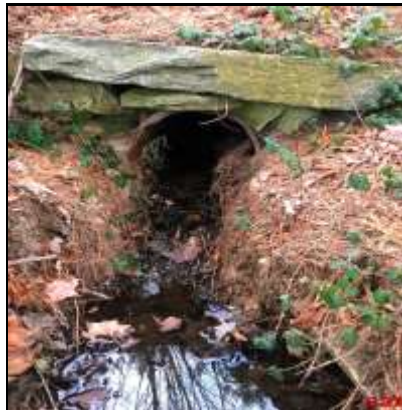
Outfall ID:	CUL-225-O
Street Name:	ARNOLD ROAD
Inlet/Outlet	Outlet
Inspection Date:	12/13/2018
Culvert Condition:	Satisfactory
Culvert Diameter:	12
Culvert Height:	0
Culvert Width:	0
Culvert Shape:	Round
Culvert Material:	CMP
Culvert Bottom Type:	Engineered
Culvert Issue:	None
Headwall Present:	Yes
Headwall Condition:	Fair
Headwall Material:	Stone
Wingwall Present:	No
Wingwall Material:	None
Wingwall Length:	0
Wingwall Condition:	None
Scouring:	No
High Water Signs:	No
Inspection Notes:	0

Visible Sediment:	Yes
Screened In:	No
Closest Pole:	11
Weather Condition:	Clear
Stream Condition:	Good
Pavement Condition:	Good
Roadway Sags:	No
Depth of Fill	12
Side Slopes	Sloped
Underground Utilities:	No

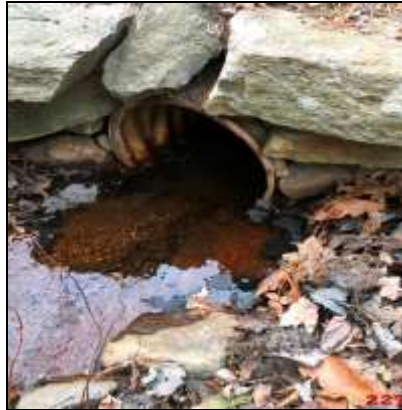
Outfall ID:	CUL-227-I
Street Name:	ARNOLD ROAD
Inlet/Outlet	Inlet
Inspection Date:	12/13/2018
Culvert Condition:	Good
Culvert Diameter:	12
Culvert Height:	0
Culvert Width:	0
Culvert Shape:	Round
Culvert Material:	CMP
Culvert Bottom Type:	Engineered
Culvert Issue:	None
Headwall Present:	Yes
Headwall Condition:	Fair
Headwall Material:	Stone
Wingwall Present:	No
Wingwall Material:	None
Wingwall Length:	0
Wingwall Condition:	None
Scouring:	No
High Water Signs:	No
Inspection Notes:	0

Visible Sediment:	Yes
Screened In:	No
Closest Pole:	11
Weather Condition:	Clear
Stream Condition:	Good
Pavement Condition:	Good
Roadway Sags:	No
Depth of Fill	18
Side Slopes	Sloped
Underground Utilities:	No

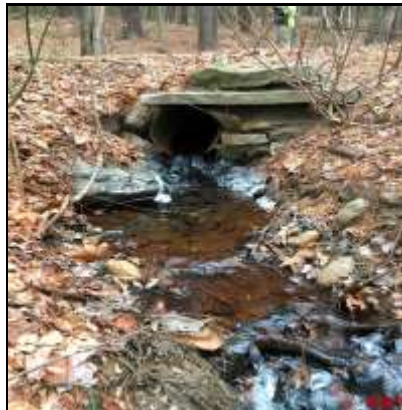
Outfall ID:	CUL-227-O
Street Name:	ARNOLD ROAD
Inlet/Outlet	Outlet
Inspection Date:	12/13/2018
Culvert Condition:	Good
Culvert Diameter:	12
Culvert Height:	0
Culvert Width:	0
Culvert Shape:	Round
Culvert Material:	CMP
Culvert Bottom Type:	Engineered
Culvert Issue:	None
Headwall Present:	Yes
Headwall Condition:	Fair
Headwall Material:	Stone
Wingwall Present:	No
Wingwall Material:	None
Wingwall Length:	0
Wingwall Condition:	None
Scouring:	No
High Water Signs:	No
Inspection Notes:	0

Visible Sediment:	Yes
Screened In:	No
Closest Pole:	11
Weather Condition:	Clear
Stream Condition:	Good
Pavement Condition:	Good
Roadway Sags:	No
Depth of Fill	18
Side Slopes	Sloped
Underground Utilities:	No

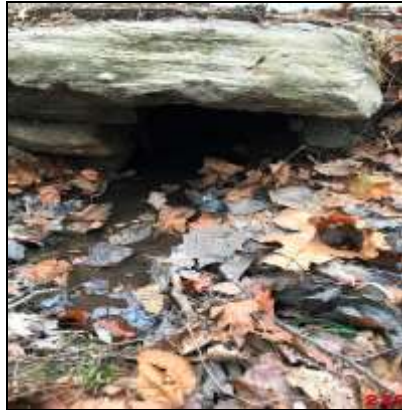
Outfall ID:	CUL-229-I
Street Name:	ARNOLD ROAD
Inlet/Outlet	Inlet
Inspection Date:	12/13/2018
Culvert Condition:	Satisfactory
Culvert Diameter:	12
Culvert Height:	0
Culvert Width:	0
Culvert Shape:	Round
Culvert Material:	CMP
Culvert Bottom Type:	Engineered
Culvert Issue:	None
Headwall Present:	Yes
Headwall Condition:	Fair
Headwall Material:	Stone
Wingwall Present:	No
Wingwall Material:	None
Wingwall Length:	0
Wingwall Condition:	None
Scouring:	No
High Water Signs:	No
Inspection Notes:	0

Visible Sediment:	Yes
Screened In:	No
Closest Pole:	16
Weather Condition:	Clear
Stream Condition:	Good
Pavement Condition:	Good
Roadway Sags:	No
Depth of Fill	12
Side Slopes	Sloped
Underground Utilities:	No

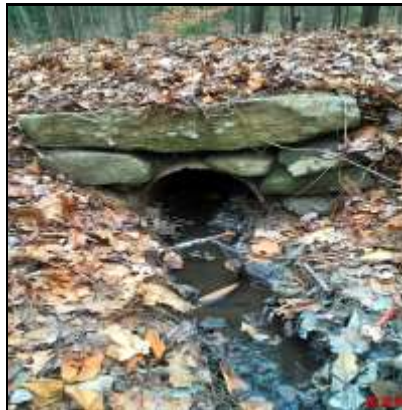
Outfall ID:	CUL-229-O
Street Name:	ARNOLD ROAD
Inlet/Outlet	Outlet
Inspection Date:	12/13/2018
Culvert Condition:	Satisfactory
Culvert Diameter:	12
Culvert Height:	0
Culvert Width:	0
Culvert Shape:	Round
Culvert Material:	CMP
Culvert Bottom Type:	Engineered
Culvert Issue:	None
Headwall Present:	Yes
Headwall Condition:	Fair
Headwall Material:	Stone
Wingwall Present:	No
Wingwall Material:	None
Wingwall Length:	0
Wingwall Condition:	None
Scouring:	No
High Water Signs:	No
Inspection Notes:	0

Visible Sediment:	Yes
Screened In:	No
Closest Pole:	16
Weather Condition:	Clear
Stream Condition:	Good
Pavement Condition:	Good
Roadway Sags:	No
Depth of Fill	12
Side Slopes	Sloped
Underground Utilities:	No

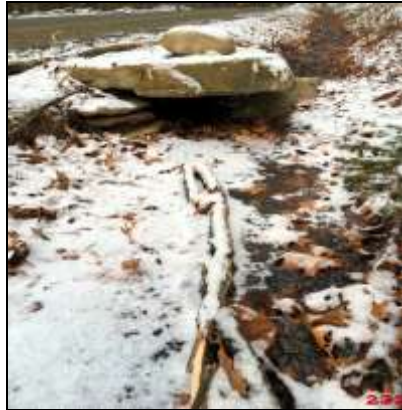
Outfall ID:	CUL-232-I
Street Name:	BUTTER HILL ROAD
Inlet/Outlet	Inlet
Inspection Date:	12/14/2018
Culvert Condition:	Fair
Culvert Diameter:	15
Culvert Height:	0
Culvert Width:	0
Culvert Shape:	Round
Culvert Material:	CMP
Culvert Bottom Type:	Engineered
Culvert Issue:	None
Headwall Present:	No
Headwall Condition:	None
Headwall Material:	None
Wingwall Present:	No
Wingwall Material:	None
Wingwall Length:	0
Wingwall Condition:	None
Scouring:	No
High Water Signs:	No
Inspection Notes:	0

Visible Sediment:	Yes
Screened In:	No
Closest Pole:	7
Weather Condition:	Cloudy
Stream Condition:	Good
Pavement Condition:	Fair
Roadway Sags:	No
Depth of Fill	12
Side Slopes	Sloped
Underground Utilities:	No

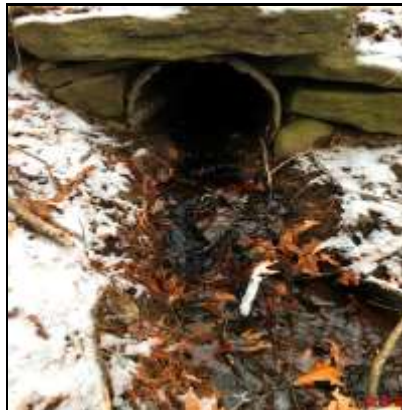
Outfall ID:	CUL-232-O
Street Name:	BUTTER HILL ROAD
Inlet/Outlet	Outlet
Inspection Date:	12/14/2018
Culvert Condition:	Satisfactory
Culvert Diameter:	15
Culvert Height:	0
Culvert Width:	0
Culvert Shape:	Round
Culvert Material:	CMP
Culvert Bottom Type:	Engineered
Culvert Issue:	None
Headwall Present:	Yes
Headwall Condition:	Fair
Headwall Material:	Stone
Wingwall Present:	No
Wingwall Material:	None
Wingwall Length:	0
Wingwall Condition:	None
Scouring:	No
High Water Signs:	No
Inspection Notes:	0

Visible Sediment:	Yes
Screened In:	No
Closest Pole:	7
Weather Condition:	Cloudy
Stream Condition:	Good
Pavement Condition:	Fair
Roadway Sags:	No
Depth of Fill	12
Side Slopes	Sloped
Underground Utilities:	No

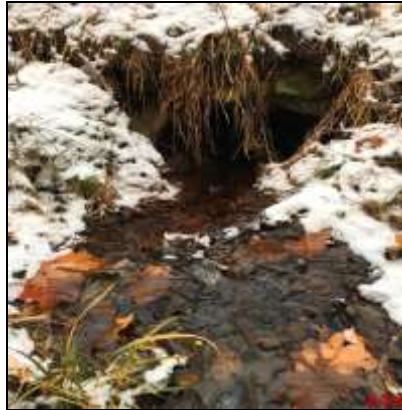
Outfall ID:	CUL-234-I
Street Name:	BUTTER HILL ROAD
Inlet/Outlet	Inlet
Inspection Date:	12/14/2018
Culvert Condition:	Poor
Culvert Diameter:	0
Culvert Height:	12
Culvert Width:	12
Culvert Shape:	Irregular
Culvert Material:	OTHER
Culvert Bottom Type:	Natural
Culvert Issue:	Blockage
Headwall Present:	Yes
Headwall Condition:	Fair
Headwall Material:	Stone
Wingwall Present:	No
Wingwall Material:	None
Wingwall Length:	0
Wingwall Condition:	None
Scouring:	No
High Water Signs:	No
Inspection Notes:	0

Visible Sediment:	Yes
Screened In:	No
Closest Pole:	6 10M
Weather Condition:	Cloudy
Stream Condition:	Good
Pavement Condition:	Poor
Roadway Sags:	No
Depth of Fill	12
Side Slopes	Sloped
Underground Utilities:	No

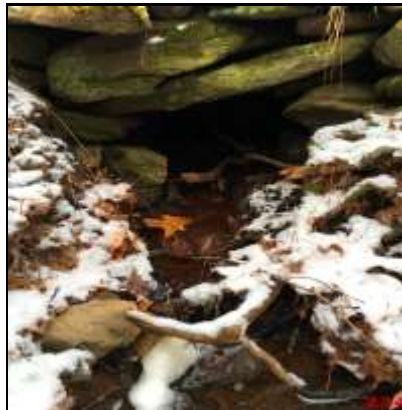
Outfall ID:	CUL-234-O
Street Name:	BUTTER HILL ROAD
Inlet/Outlet	Outlet
Inspection Date:	12/14/2018
Culvert Condition:	Poor
Culvert Diameter:	0
Culvert Height:	12
Culvert Width:	12
Culvert Shape:	Irregular
Culvert Material:	OTHER
Culvert Bottom Type:	Natural
Culvert Issue:	Blockage
Headwall Present:	Yes
Headwall Condition:	Fair
Headwall Material:	Stone
Wingwall Present:	No
Wingwall Material:	None
Wingwall Length:	0
Wingwall Condition:	None
Scouring:	No
High Water Signs:	No
Inspection Notes:	0

Visible Sediment:	Yes
Screened In:	No
Closest Pole:	6 10M
Weather Condition:	Cloudy
Stream Condition:	Good
Pavement Condition:	Poor
Roadway Sags:	No
Depth of Fill	12
Side Slopes	Sloped
Underground Utilities:	No

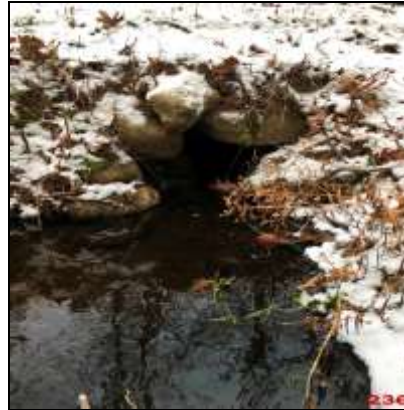
Outfall ID:	CUL-236-I
Street Name:	BUTTER HILL ROAD
Inlet/Outlet	Inlet
Inspection Date:	12/14/2018
Culvert Condition:	Fair
Culvert Diameter:	15
Culvert Height:	0
Culvert Width:	0
Culvert Shape:	Round
Culvert Material:	CMP
Culvert Bottom Type:	Engineered
Culvert Issue:	Pipe bottom starting to rust
Headwall Present:	Yes
Headwall Condition:	Fair
Headwall Material:	Stone
Wingwall Present:	No
Wingwall Material:	None
Wingwall Length:	0
Wingwall Condition:	None
Scouring:	No
High Water Signs:	No
Inspection Notes:	0

Visible Sediment:	Yes
Screened In:	No
Closest Pole:	6 10M
Weather Condition:	Cloudy
Stream Condition:	Good
Pavement Condition:	Poor
Roadway Sags:	No
Depth of Fill	18
Side Slopes	Sloped
Underground Utilities:	No

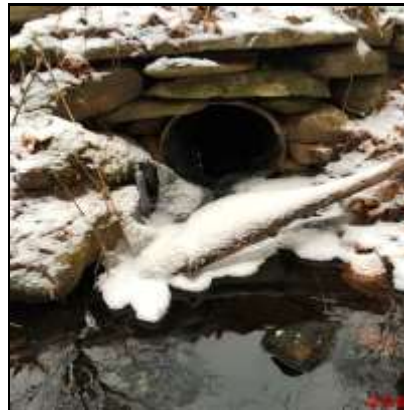
Outfall ID:	CUL-236-O
Street Name:	BUTTER HILL ROAD
Inlet/Outlet	Outlet
Inspection Date:	12/14/2018
Culvert Condition:	Fair
Culvert Diameter:	15
Culvert Height:	0
Culvert Width:	0
Culvert Shape:	Round
Culvert Material:	CMP
Culvert Bottom Type:	Engineered
Culvert Issue:	Pipe bottom starting to rust
Headwall Present:	Yes
Headwall Condition:	Fair
Headwall Material:	Stone
Wingwall Present:	No
Wingwall Material:	None
Wingwall Length:	0
Wingwall Condition:	None
Scouring:	No
High Water Signs:	No
Inspection Notes:	0

Visible Sediment:	Yes
Screened In:	No
Closest Pole:	6 10M
Weather Condition:	Cloudy
Stream Condition:	Good
Pavement Condition:	Poor
Roadway Sags:	No
Depth of Fill	18
Side Slopes	Sloped
Underground Utilities:	No

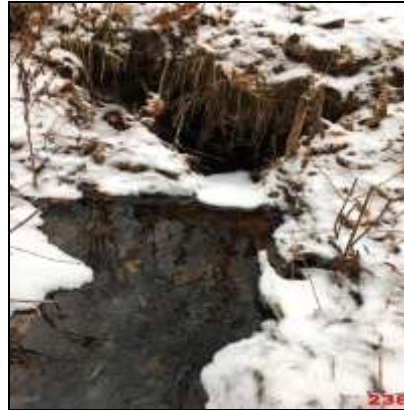
Outfall ID:	CUL-238-I
Street Name:	PACKARDVILLE ROAD
Inlet/Outlet	Inlet
Inspection Date:	12/14/2018
Culvert Condition:	Poor
Culvert Diameter:	18
Culvert Height:	0
Culvert Width:	0
Culvert Shape:	Round
Culvert Material:	CMP
Culvert Bottom Type:	Engineered
Culvert Issue:	Pipe bottom rusted out
Headwall Present:	Yes
Headwall Condition:	Fair
Headwall Material:	Stone
Wingwall Present:	No
Wingwall Material:	None
Wingwall Length:	0
Wingwall Condition:	None
Scouring:	No
High Water Signs:	No
Inspection Notes:	0

Visible Sediment:	Yes
Screened In:	No
Closest Pole:	10 28S
Weather Condition:	Cloudy
Stream Condition:	Good
Pavement Condition:	Good
Roadway Sags:	No
Depth of Fill	24
Side Slopes	Sloped
Underground Utilities:	No

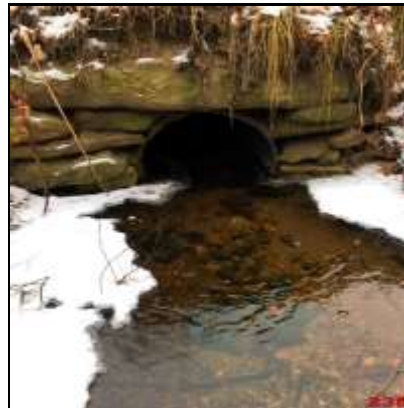
Outfall ID:	CUL-238-O
Street Name:	PACKARDVILLE ROAD
Inlet/Outlet	Outlet
Inspection Date:	12/14/2018
Culvert Condition:	Poor
Culvert Diameter:	18
Culvert Height:	0
Culvert Width:	0
Culvert Shape:	Round
Culvert Material:	CMP
Culvert Bottom Type:	Engineered
Culvert Issue:	Pipe bottom rusted out
Headwall Present:	Yes
Headwall Condition:	Good
Headwall Material:	Stone
Wingwall Present:	No
Wingwall Material:	None
Wingwall Length:	0
Wingwall Condition:	None
Scouring:	No
High Water Signs:	No
Inspection Notes:	0

Visible Sediment:	No
Screened In:	No
Closest Pole:	10 28S
Weather Condition:	Cloudy
Stream Condition:	Good
Pavement Condition:	Good
Roadway Sags:	No
Depth of Fill	24
Side Slopes	Sloped
Underground Utilities:	No

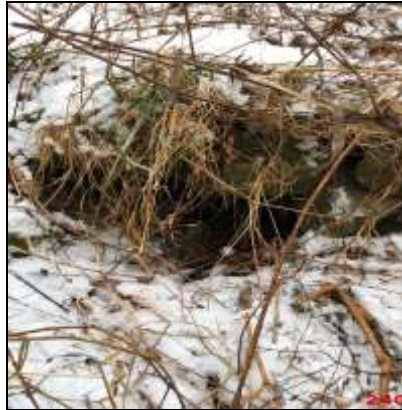
Outfall ID:	CUL-240-I
Street Name:	GULF ROAD
Inlet/Outlet	Inlet
Inspection Date:	12/14/2018
Culvert Condition:	Poor
Culvert Diameter:	12
Culvert Height:	0
Culvert Width:	0
Culvert Shape:	Round
Culvert Material:	RCP
Culvert Bottom Type:	Engineered
Culvert Issue:	Major blockage
Headwall Present:	Yes
Headwall Condition:	Fair
Headwall Material:	Stone
Wingwall Present:	No
Wingwall Material:	None
Wingwall Length:	0
Wingwall Condition:	None
Scouring:	No
High Water Signs:	No
Inspection Notes:	0

Visible Sediment:	Yes
Screened In:	No
Closest Pole:	12 10
Weather Condition:	Cloudy
Stream Condition:	Good
Pavement Condition:	Fair
Roadway Sags:	No
Depth of Fill	18
Side Slopes	Sloped
Underground Utilities:	No

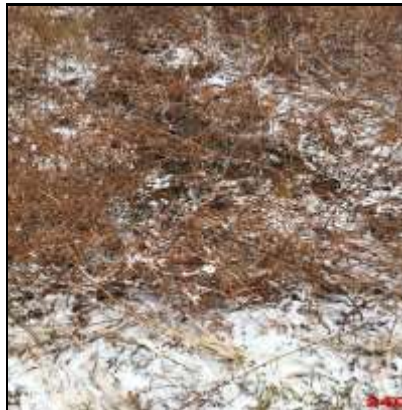
Outfall ID:	CUL-240-O
Street Name:	GULF ROAD
Inlet/Outlet	Outlet
Inspection Date:	12/14/2018
Culvert Condition:	Poor
Culvert Diameter:	12
Culvert Height:	0
Culvert Width:	0
Culvert Shape:	Round
Culvert Material:	RCP
Culvert Bottom Type:	Engineered
Culvert Issue:	Major blockage
Headwall Present:	Unknown
Headwall Condition:	Unknown
Headwall Material:	Unknown
Wingwall Present:	Unknown
Wingwall Material:	Unknown
Wingwall Length:	Unknown
Wingwall Condition:	Unknown
Scouring:	No
High Water Signs:	No
Inspection Notes:	Downstream structure buried

Visible Sediment:	Yes
Screened In:	No
Closest Pole:	12 10
Weather Condition:	Cloudy
Stream Condition:	Good
Pavement Condition:	Fair
Roadway Sags:	No
Depth of Fill	18
Side Slopes	Sloped
Underground Utilities:	No

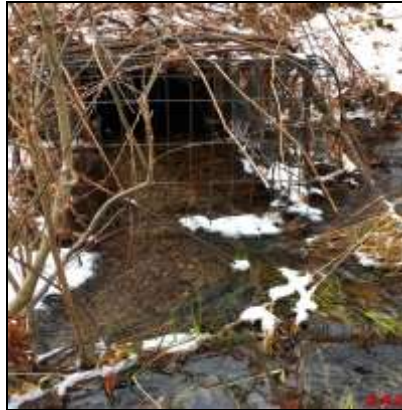
Outfall ID:	CUL-242-I
Street Name:	PACKARDVILLE ROAD
Inlet/Outlet	Inlet
Inspection Date:	12/14/2018
Culvert Condition:	Satisfactory
Culvert Diameter:	18
Culvert Height:	0
Culvert Width:	0
Culvert Shape:	Round
Culvert Material:	HDPE
Culvert Bottom Type:	Engineered
Culvert Issue:	None
Headwall Present:	Yes
Headwall Condition:	Fair
Headwall Material:	Stone
Wingwall Present:	No
Wingwall Material:	None
Wingwall Length:	0
Wingwall Condition:	None
Scouring:	No
High Water Signs:	No
Inspection Notes:	0

Visible Sediment:	No
Screened In:	Yes
Closest Pole:	6M
Weather Condition:	Cloudy
Stream Condition:	Good
Pavement Condition:	Good
Roadway Sags:	No
Depth of Fill	24
Side Slopes	Sloped
Underground Utilities:	No

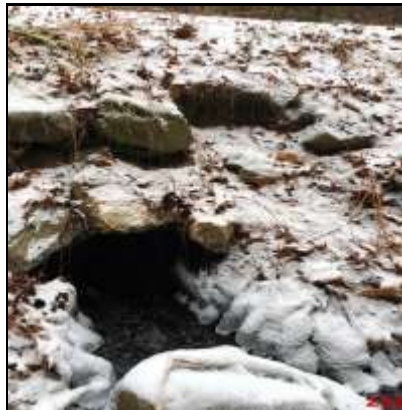
Outfall ID:	CUL-242-O
Street Name:	PACKARDVILLE ROAD
Inlet/Outlet	Outlet
Inspection Date:	12/14/2018
Culvert Condition:	Satisfactory
Culvert Diameter:	18
Culvert Height:	0
Culvert Width:	0
Culvert Shape:	Round
Culvert Material:	HDPE
Culvert Bottom Type:	Engineered
Culvert Issue:	None
Headwall Present:	Yes
Headwall Condition:	Fair
Headwall Material:	Stone
Wingwall Present:	No
Wingwall Material:	None
Wingwall Length:	0
Wingwall Condition:	None
Scouring:	No
High Water Signs:	No
Inspection Notes:	0

Visible Sediment:	No
Screened In:	No
Closest Pole:	6M
Weather Condition:	Cloudy
Stream Condition:	Good
Pavement Condition:	Good
Roadway Sags:	No
Depth of Fill	24
Side Slopes	Sloped
Underground Utilities:	No

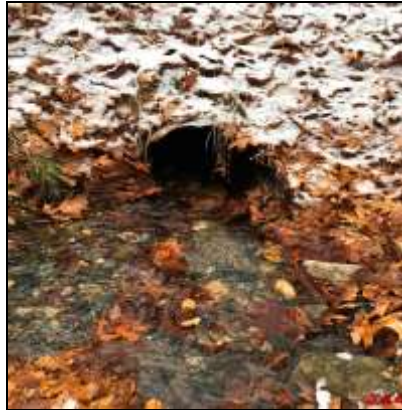
Outfall ID:	CUL-244-I
Street Name:	PACKARDVILLE ROAD
Inlet/Outlet	Inlet
Inspection Date:	12/14/2018
Culvert Condition:	Poor
Culvert Diameter:	15
Culvert Height:	0
Culvert Width:	0
Culvert Shape:	Round
Culvert Material:	CMP
Culvert Bottom Type:	Engineered
Culvert Issue:	Pipe bottom rusted out
Headwall Present:	No
Headwall Condition:	None
Headwall Material:	None
Wingwall Present:	No
Wingwall Material:	None
Wingwall Length:	0
Wingwall Condition:	None
Scouring:	No
High Water Signs:	No
Inspection Notes:	0

Visible Sediment:	Yes
Screened In:	No
Closest Pole:	25T
Weather Condition:	Cloudy
Stream Condition:	Good
Pavement Condition:	Fair
Roadway Sags:	No
Depth of Fill	30
Side Slopes	Sloped
Underground Utilities:	No

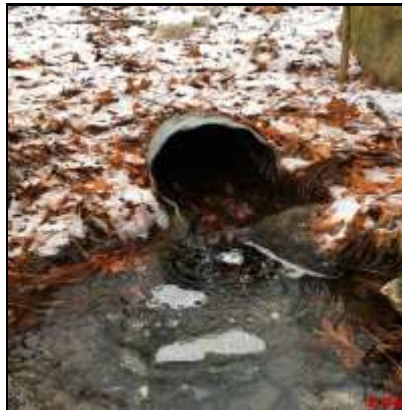
Outfall ID:	CUL-244-O
Street Name:	PACKARDVILLE ROAD
Inlet/Outlet	Outlet
Inspection Date:	12/14/2018
Culvert Condition:	Poor
Culvert Diameter:	15
Culvert Height:	0
Culvert Width:	0
Culvert Shape:	Round
Culvert Material:	CMP
Culvert Bottom Type:	Engineered
Culvert Issue:	Pipe bottom rusted out
Headwall Present:	No
Headwall Condition:	None
Headwall Material:	None
Wingwall Present:	No
Wingwall Material:	None
Wingwall Length:	0
Wingwall Condition:	None
Scouring:	No
High Water Signs:	No
Inspection Notes:	0

Visible Sediment:	Yes
Screened In:	No
Closest Pole:	25T
Weather Condition:	Cloudy
Stream Condition:	Good
Pavement Condition:	Fair
Roadway Sags:	No
Depth of Fill	30
Side Slopes	Sloped
Underground Utilities:	No

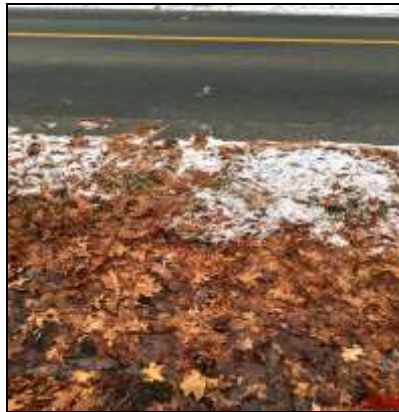
Outfall ID:	CUL-246-I
Street Name:	PACKARDVILLE ROAD
Inlet/Outlet	Inlet
Inspection Date:	12/14/2018
Culvert Condition:	Unknown
Culvert Diameter:	15
Culvert Height:	0
Culvert Width:	0
Culvert Shape:	Round
Culvert Material:	HDPE
Culvert Bottom Type:	Engineered
Culvert Issue:	Blockage
Headwall Present:	Unknown
Headwall Condition:	Unknown
Headwall Material:	Unknown
Wingwall Present:	Unknown
Wingwall Material:	Unknown
Wingwall Length:	Unknown
Wingwall Condition:	Unknown
Scouring:	No
High Water Signs:	No
Inspection Notes:	Upstream end buried

Visible Sediment:	Yes
Screened In:	No
Closest Pole:	16
Weather Condition:	Cloudy
Stream Condition:	Blockage
Pavement Condition:	Fair
Roadway Sags:	No
Depth of Fill	12
Side Slopes	Sloped
Underground Utilities:	No

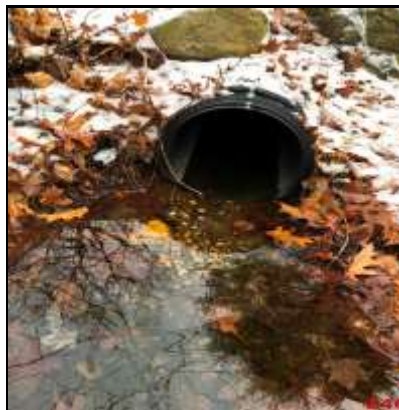
Outfall ID:	CUL-246-O
Street Name:	PACKARDVILLE ROAD
Inlet/Outlet	Outlet
Inspection Date:	12/14/2018
Culvert Condition:	Good
Culvert Diameter:	15
Culvert Height:	0
Culvert Width:	0
Culvert Shape:	Round
Culvert Material:	HDPE
Culvert Bottom Type:	Engineered
Culvert Issue:	Blockage
Headwall Present:	No
Headwall Condition:	None
Headwall Material:	None
Wingwall Present:	No
Wingwall Material:	None
Wingwall Length:	0
Wingwall Condition:	None
Scouring:	No
High Water Signs:	No
Inspection Notes:	0

Visible Sediment:	No
Screened In:	No
Closest Pole:	16
Weather Condition:	Cloudy
Stream Condition:	Good
Pavement Condition:	Fair
Roadway Sags:	No
Depth of Fill	12
Side Slopes	Sloped
Underground Utilities:	No

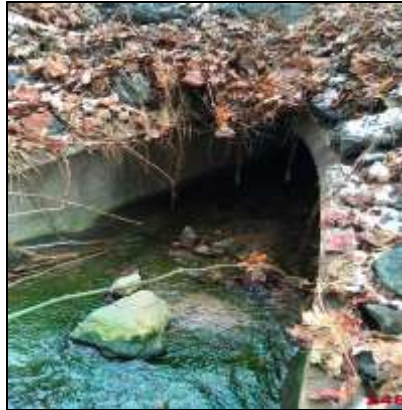
Outfall ID:	CUL-248-I
Street Name:	AMHERST ROAD
Inlet/Outlet	Inlet
Inspection Date:	12/14/2018
Culvert Condition:	Good
Culvert Diameter:	24
Culvert Height:	0
Culvert Width:	0
Culvert Shape:	Round
Culvert Material:	RCP
Culvert Bottom Type:	Engineered
Culvert Issue:	None
Headwall Present:	No
Headwall Condition:	None
Headwall Material:	None
Wingwall Present:	No
Wingwall Material:	None
Wingwall Length:	0
Wingwall Condition:	None
Scouring:	No
High Water Signs:	No
Inspection Notes:	0

Visible Sediment:	No
Screened In:	No
Closest Pole:	63
Weather Condition:	Cloudy
Stream Condition:	Good
Pavement Condition:	Good
Roadway Sags:	No
Depth of Fill	30
Side Slopes	Sloped
Underground Utilities:	No

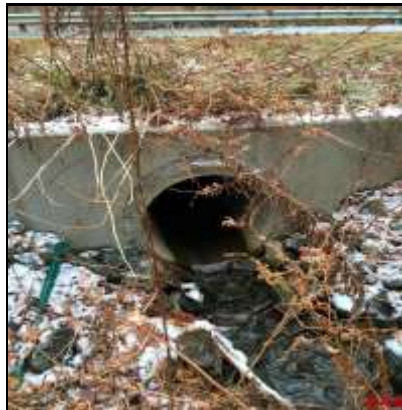
Outfall ID:	CUL-248-O
Street Name:	AMHERST ROAD
Inlet/Outlet	Outlet
Inspection Date:	12/14/2018
Culvert Condition:	Good
Culvert Diameter:	24
Culvert Height:	0
Culvert Width:	0
Culvert Shape:	Round
Culvert Material:	RCP
Culvert Bottom Type:	Engineered
Culvert Issue:	None
Headwall Present:	Yes
Headwall Condition:	Good
Headwall Material:	Concrete
Wingwall Present:	No
Wingwall Material:	None
Wingwall Length:	0
Wingwall Condition:	None
Scouring:	No
High Water Signs:	No
Inspection Notes:	0

Visible Sediment:	No
Screened In:	No
Closest Pole:	63
Weather Condition:	Cloudy
Stream Condition:	Good
Pavement Condition:	Good
Roadway Sags:	No
Depth of Fill	24
Side Slopes	Sloped
Underground Utilities:	No

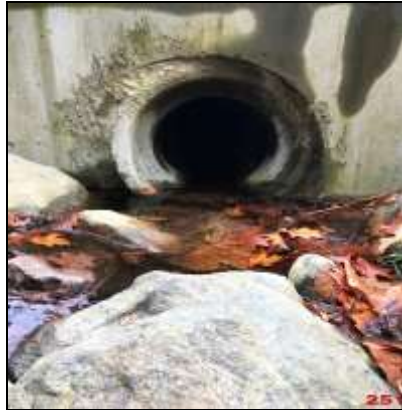
Outfall ID:	CUL-251-I
Street Name:	AMHERST ROAD
Inlet/Outlet	Inlet
Inspection Date:	12/14/2018
Culvert Condition:	Good
Culvert Diameter:	15
Culvert Height:	0
Culvert Width:	0
Culvert Shape:	Round
Culvert Material:	RCP
Culvert Bottom Type:	Engineered
Culvert Issue:	None
Headwall Present:	Yes
Headwall Condition:	Good
Headwall Material:	Concrete
Wingwall Present:	No
Wingwall Material:	None
Wingwall Length:	0
Wingwall Condition:	None
Scouring:	No
High Water Signs:	No
Inspection Notes:	0

Visible Sediment:	No
Screened In:	No
Closest Pole:	102
Weather Condition:	Cloudy
Stream Condition:	Good
Pavement Condition:	Good
Roadway Sags:	No
Depth of Fill	18
Side Slopes	Sloped
Underground Utilities:	No

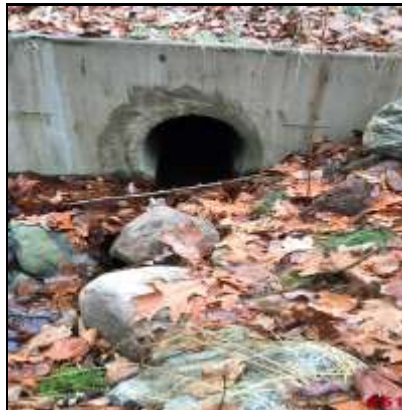
Outfall ID:	CUL-251-O
Street Name:	AMHERST ROAD
Inlet/Outlet	Outlet
Inspection Date:	12/14/2018
Culvert Condition:	Good
Culvert Diameter:	15
Culvert Height:	0
Culvert Width:	0
Culvert Shape:	Round
Culvert Material:	RCP
Culvert Bottom Type:	Engineered
Culvert Issue:	None
Headwall Present:	Yes
Headwall Condition:	Good
Headwall Material:	Concrete
Wingwall Present:	No
Wingwall Material:	None
Wingwall Length:	0
Wingwall Condition:	None
Scouring:	No
High Water Signs:	No
Inspection Notes:	0

Visible Sediment:	No
Screened In:	No
Closest Pole:	102
Weather Condition:	Cloudy
Stream Condition:	Good
Pavement Condition:	Good
Roadway Sags:	No
Depth of Fill	24
Side Slopes	Sloped
Underground Utilities:	No
