Stormwater Management Culvert Inventory

Town of Pelham, Massachusetts

Date: June 3, 2019

Date of Inspections: Winter 2018

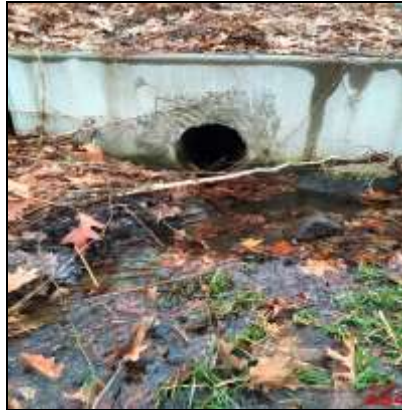
Outfall ID:	CUL-254-I
Street Name:	AMHERST ROAD
Inlet/Outlet	Inlet
Inspection Date:	12/14/2018
Culvert Condition:	Good
Culvert Diameter:	12
Culvert Height:	0
Culvert Width:	0
Culvert Shape:	Round
Culvert Material:	RCP
Culvert Bottom Type:	Engineered
Culvert Issue:	None
Headwall Present:	Yes
Headwall Condition:	Good
Headwall Material:	Concrete
Wingwall Present:	No
Wingwall Material:	None
Wingwall Length:	0
Wingwall Condition:	None
Scouring:	No
High Water Signs:	No
Inspection Notes:	0

Visible Sediment:	No
Screened In:	No
Closest Pole:	10T
Weather Condition:	Cloudy
Stream Condition:	Good
Pavement Condition:	Good
Roadway Sags:	No
Depth of Fill	24
Side Slopes	Sloped
Underground Utilities:	No

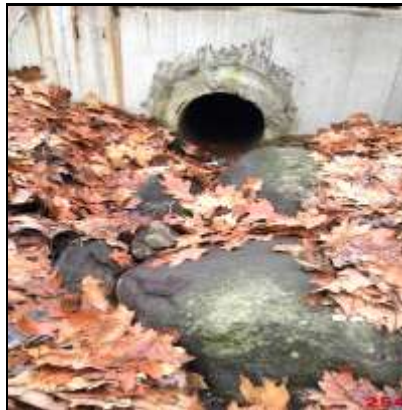
Outfall ID:	CUL-254-O
Street Name:	AMHERST ROAD
Inlet/Outlet	Outlet
Inspection Date:	12/14/2018
Culvert Condition:	Good
Culvert Diameter:	12
Culvert Height:	0
Culvert Width:	0
Culvert Shape:	Round
Culvert Material:	RCP
Culvert Bottom Type:	Engineered
Culvert Issue:	None
Headwall Present:	Yes
Headwall Condition:	Good
Headwall Material:	Concrete
Wingwall Present:	No
Wingwall Material:	None
Wingwall Length:	0
Wingwall Condition:	None
Scouring:	No
High Water Signs:	No
Inspection Notes:	0

Visible Sediment:	Yes
Screened In:	No
Closest Pole:	10T
Weather Condition:	Cloudy
Stream Condition:	Good
Pavement Condition:	Good
Roadway Sags:	No
Depth of Fill	24
Side Slopes	Sloped
Underground Utilities:	No

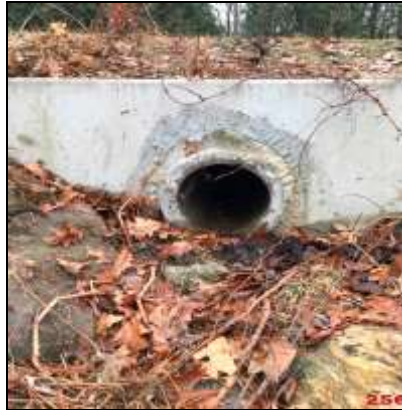
Outfall ID:	CUL-256-I
Street Name:	AMHERST ROAD
Inlet/Outlet	Inlet
Inspection Date:	12/14/2018
Culvert Condition:	Good
Culvert Diameter:	12
Culvert Height:	0
Culvert Width:	0
Culvert Shape:	Round
Culvert Material:	RCP
Culvert Bottom Type:	Engineered
Culvert Issue:	None
Headwall Present:	Yes
Headwall Condition:	Good
Headwall Material:	Concrete
Wingwall Present:	No
Wingwall Material:	None
Wingwall Length:	0
Wingwall Condition:	None
Scouring:	No
High Water Signs:	No
Inspection Notes:	0

Visible Sediment:	Yes
Screened In:	No
Closest Pole:	1B 122
Weather Condition:	Cloudy
Stream Condition:	Good
Pavement Condition:	Good
Roadway Sags:	No
Depth of Fill	18
Side Slopes	Sloped
Underground Utilities:	No

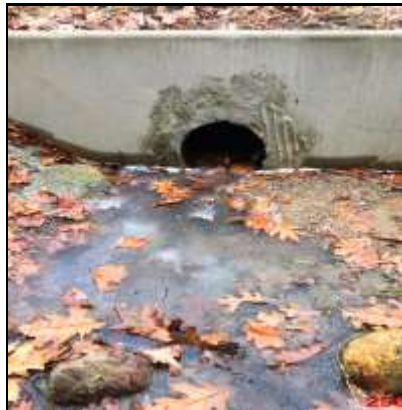
Outfall ID:	CUL-256-O
Street Name:	AMHERST ROAD
Inlet/Outlet	Outlet
Inspection Date:	12/14/2018
Culvert Condition:	Good
Culvert Diameter:	12
Culvert Height:	0
Culvert Width:	0
Culvert Shape:	Round
Culvert Material:	RCP
Culvert Bottom Type:	Engineered
Culvert Issue:	None
Headwall Present:	Yes
Headwall Condition:	Good
Headwall Material:	Concrete
Wingwall Present:	No
Wingwall Material:	None
Wingwall Length:	0
Wingwall Condition:	None
Scouring:	No
High Water Signs:	No
Inspection Notes:	0

Visible Sediment:	Yes
Screened In:	No
Closest Pole:	1B 122
Weather Condition:	Cloudy
Stream Condition:	Good
Pavement Condition:	Good
Roadway Sags:	No
Depth of Fill	18
Side Slopes	Sloped
Underground Utilities:	No

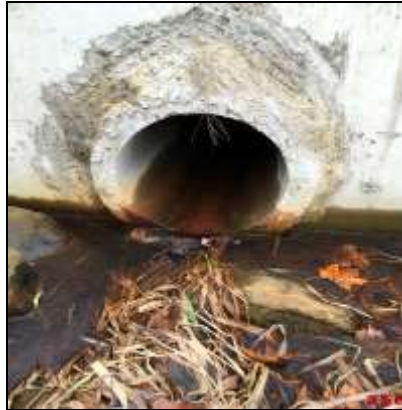
Outfall ID:	CUL-259-I
Street Name:	AMHERST ROAD
Inlet/Outlet	Inlet
Inspection Date:	12/14/2018
Culvert Condition:	Good
Culvert Diameter:	15
Culvert Height:	0
Culvert Width:	0
Culvert Shape:	Round
Culvert Material:	RCP
Culvert Bottom Type:	Engineered
Culvert Issue:	None
Headwall Present:	Yes
Headwall Condition:	Good
Headwall Material:	Concrete
Wingwall Present:	No
Wingwall Material:	None
Wingwall Length:	0
Wingwall Condition:	None
Scouring:	No
High Water Signs:	No
Inspection Notes:	0

Visible Sediment:	No
Screened In:	No
Closest Pole:	129
Weather Condition:	Cloudy
Stream Condition:	Good
Pavement Condition:	Good
Roadway Sags:	No
Depth of Fill	18
Side Slopes	Sloped
Underground Utilities:	No

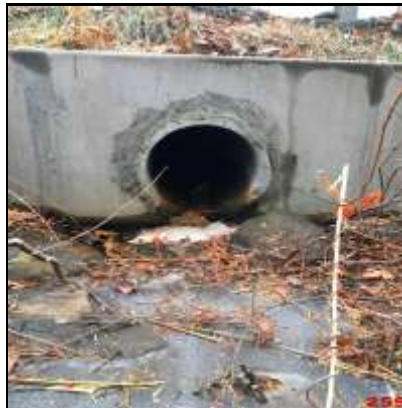
Outfall ID:	CUL-259-O
Street Name:	AMHERST ROAD
Inlet/Outlet	Outlet
Inspection Date:	12/14/2018
Culvert Condition:	Good
Culvert Diameter:	15
Culvert Height:	0
Culvert Width:	0
Culvert Shape:	Round
Culvert Material:	RCP
Culvert Bottom Type:	Engineered
Culvert Issue:	None
Headwall Present:	Yes
Headwall Condition:	Good
Headwall Material:	Concrete
Wingwall Present:	No
Wingwall Material:	None
Wingwall Length:	0
Wingwall Condition:	None
Scouring:	No
High Water Signs:	No
Inspection Notes:	0

Visible Sediment:	No
Screened In:	No
Closest Pole:	129
Weather Condition:	Cloudy
Stream Condition:	Red algae
Pavement Condition:	Good
Roadway Sags:	No
Depth of Fill	18
Side Slopes	Sloped
Underground Utilities:	No

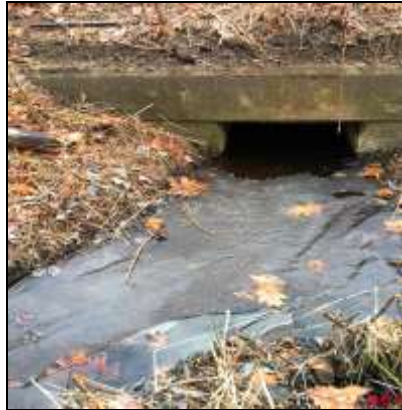
Outfall ID:	CUL-261-I
Street Name:	AMHERST ROAD
Inlet/Outlet	Inlet
Inspection Date:	12/14/2018
Culvert Condition:	Fair
Culvert Diameter:	0
Culvert Height:	24
Culvert Width:	24
Culvert Shape:	Box
Culvert Material:	RCP
Culvert Bottom Type:	Natural
Culvert Issue:	None
Headwall Present:	Yes
Headwall Condition:	Unknown
Headwall Material:	Concrete
Wingwall Present:	No
Wingwall Material:	None
Wingwall Length:	0
Wingwall Condition:	None
Scouring:	No
High Water Signs:	No
Inspection Notes:	Upstream structure under ice sheet

Visible Sediment:	No
Screened In:	No
Closest Pole:	132
Weather Condition:	Cloudy
Stream Condition:	Good
Pavement Condition:	Good
Roadway Sags:	No
Depth of Fill	24
Side Slopes	Sloped
Underground Utilities:	No

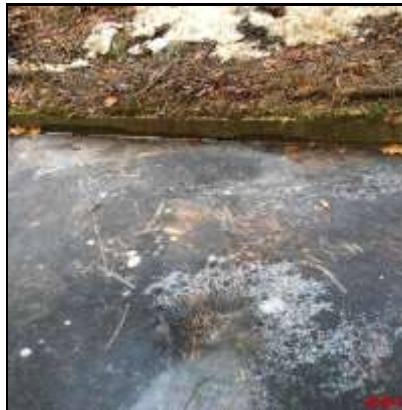
Outfall ID:	CUL-261-O
Street Name:	AMHERST ROAD
Inlet/Outlet	Outlet
Inspection Date:	12/14/2018
Culvert Condition:	Satisfactory
Culvert Diameter:	0
Culvert Height:	24
Culvert Width:	24
Culvert Shape:	Box
Culvert Material:	RCP
Culvert Bottom Type:	Natural
Culvert Issue:	None
Headwall Present:	Yes
Headwall Condition:	Fair
Headwall Material:	Concrete
Wingwall Present:	No
Wingwall Material:	None
Wingwall Length:	0
Wingwall Condition:	None
Scouring:	No
High Water Signs:	No
Inspection Notes:	0

Visible Sediment:	No
Screened In:	No
Closest Pole:	132
Weather Condition:	Cloudy
Stream Condition:	Good
Pavement Condition:	Good
Roadway Sags:	No
Depth of Fill	36
Side Slopes	Sloped
Underground Utilities:	No

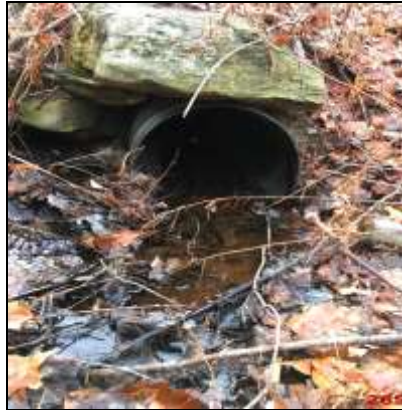
Outfall ID:	CUL-265-I
Street Name:	PACKARDVILLE ROAD
Inlet/Outlet	Inlet
Inspection Date:	12/14/2018
Culvert Condition:	Satisfactory
Culvert Diameter:	15
Culvert Height:	0
Culvert Width:	0
Culvert Shape:	Round
Culvert Material:	HDPE
Culvert Bottom Type:	Engineered
Culvert Issue:	None
Headwall Present:	No
Headwall Condition:	None
Headwall Material:	None
Wingwall Present:	No
Wingwall Material:	None
Wingwall Length:	0
Wingwall Condition:	None
Scouring:	No
High Water Signs:	No
Inspection Notes:	0

Visible Sediment:	Yes
Screened In:	No
Closest Pole:	19 77
Weather Condition:	Cloudy
Stream Condition:	Good
Pavement Condition:	Poor
Roadway Sags:	No
Depth of Fill	24
Side Slopes	Sloped
Underground Utilities:	No

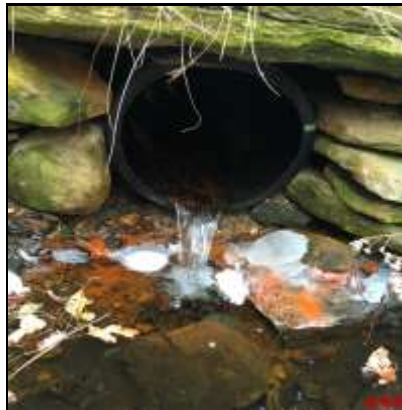
Outfall ID:	CUL-265-O
Street Name:	PACKARDVILLE ROAD
Inlet/Outlet	Outlet
Inspection Date:	12/14/2018
Culvert Condition:	Satisfactory
Culvert Diameter:	15
Culvert Height:	0
Culvert Width:	0
Culvert Shape:	Round
Culvert Material:	HDPE
Culvert Bottom Type:	Engineered
Culvert Issue:	None
Headwall Present:	No
Headwall Condition:	None
Headwall Material:	None
Wingwall Present:	No
Wingwall Material:	None
Wingwall Length:	0
Wingwall Condition:	None
Scouring:	No
High Water Signs:	No
Inspection Notes:	0

Visible Sediment:	No
Screened In:	No
Closest Pole:	19 77
Weather Condition:	Cloudy
Stream Condition:	Good
Pavement Condition:	Poor
Roadway Sags:	No
Depth of Fill	24
Side Slopes	Flat
Underground Utilities:	No

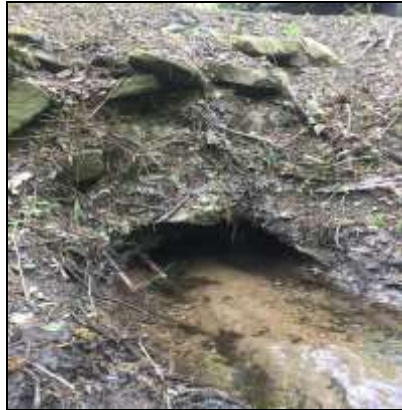
Outfall ID:	CUL-266-I
Street Name:	QUARRY ROAD
Inlet/Outlet	Inlet
Inspection Date:	5/24/2019
Culvert Condition:	Fair
Culvert Diameter:	24
Culvert Height:	0
Culvert Width:	0
Culvert Shape:	Round
Culvert Material:	CMP
Culvert Bottom Type:	N/A
Culvert Issue:	iment buildup, headwall deteriorat
Headwall Present:	Yes
Headwall Condition:	Poor
Headwall Material:	Stone
Wingwall Present:	No
Wingwall Material:	None
Wingwall Length:	0
Wingwall Condition:	None
Scouring:	No
High Water Signs:	No
Inspection Notes:	0

Visible Sediment:	Yes
Screened In:	No
Closest Pole:	42
Weather Condition:	Clear
Stream Condition:	Good
Pavement Condition:	Dirt/Gravel
Roadway Sags:	No
Depth of Fill	60
Side Slopes	Sloped
Underground Utilities:	No

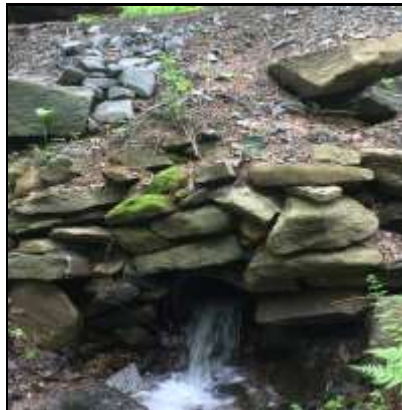
Outfall ID:	CUL-266-O
Street Name:	QUARRY ROAD
Inlet/Outlet	Outlet
Inspection Date:	5/24/2019
Culvert Condition:	Fair
Culvert Diameter:	24
Culvert Height:	0
Culvert Width:	0
Culvert Shape:	Round
Culvert Material:	CMP
Culvert Bottom Type:	N/A
Culvert Issue:	None
Headwall Present:	Yes
Headwall Condition:	Fair
Headwall Material:	Stone
Wingwall Present:	No
Wingwall Material:	None
Wingwall Length:	0
Wingwall Condition:	None
Scouring:	No
High Water Signs:	No
Inspection Notes:	0

Visible Sediment:	Yes
Screened In:	No
Closest Pole:	42
Weather Condition:	Clear
Stream Condition:	Good
Pavement Condition:	Dirt/Gravel
Roadway Sags:	No
Depth of Fill	60
Side Slopes	Sloped
Underground Utilities:	No
